Journal of Building Engineering

Experimental investigations on the bond performance of reinforced concrete beam with lap splices after fire exposure

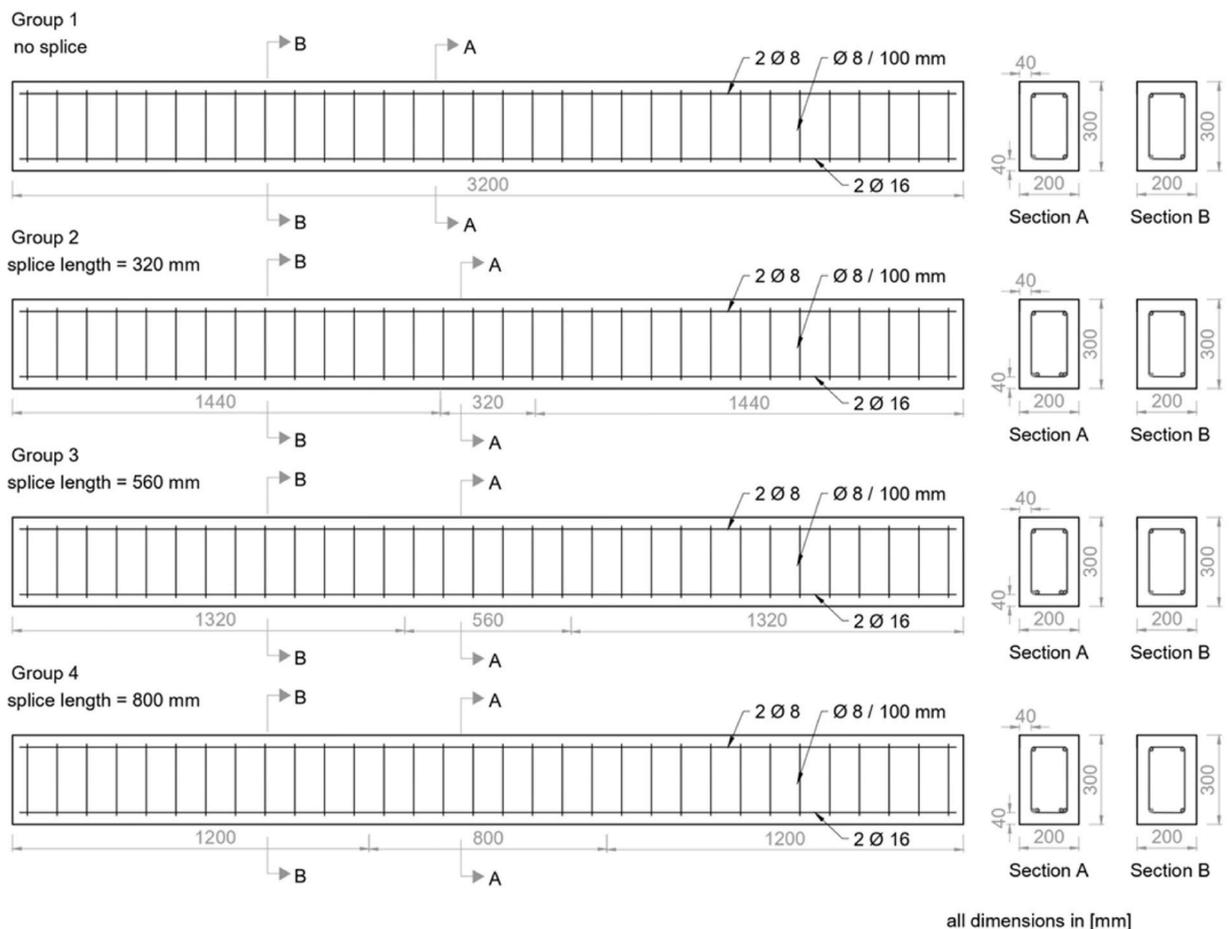
Fig. 1. Details of test specimens.

Eight reinforced concrete beams with rectangular cross-sections measuring 200 mm in width and 300 mm in height were tested. The beams featured a simply supported overall length of 3.2 m with a distance of 3 m between the supports. A total of four groups with 2 beams (one tested under ambient conditions and one tested after exposure to fire) per group were analysed (note that, Group 1 beams were tested by Sharma et al. [13], a detailed description can be found in 3.3.1). Fig. 1 presents the geometry, reinforcement configuration and dimensions of the tested beam groups. Each beam was reinforced with two tension rebars on the tension side and two continuous rebars in the compression zone, regardless of whether the beam had a tension lap splice or not. For beams with lap splices, four rebars were used in the splice region of the tension zone. The rebars in the tension zone were positioned with an axis distance of 48 mm from the bottom and side faces of the beam (providing 40 mm of clear cover). The tension zone was reinforced with two 16 mm deformed steel rebars, and compression zone were reinforced with two 8 mm deformed steel rebars. Shear reinforcement was provided by 8 mm diameter stirrups spaced at 100 mm c/c along the entire length of the beam. The reinforcement cages were secured using iron wires. Four different beam configurations were considered: i) group 1 - reference beams with continuous reinforcement, ii) group 2 - beams with lap splice length of 320 mm ($20d_s$), iii) group 3 - beams with lap splice length of 560 mm ($35d_s$) and iv) group 4 - beams with lap splice length of 800 mm ($50d_s$).

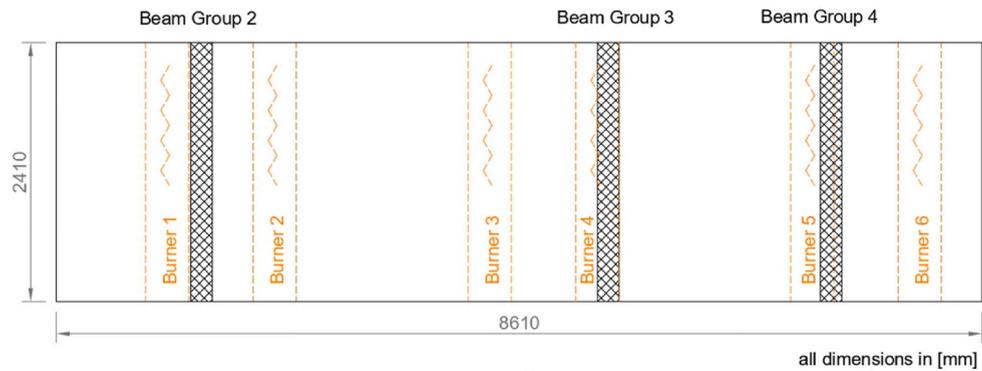
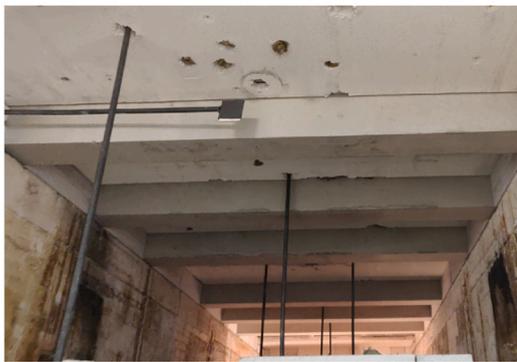
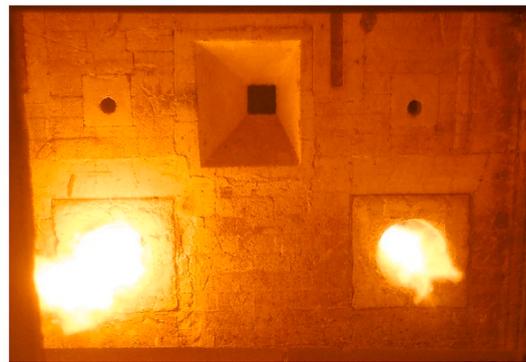
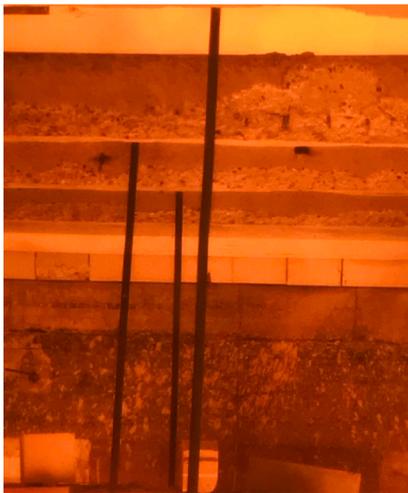
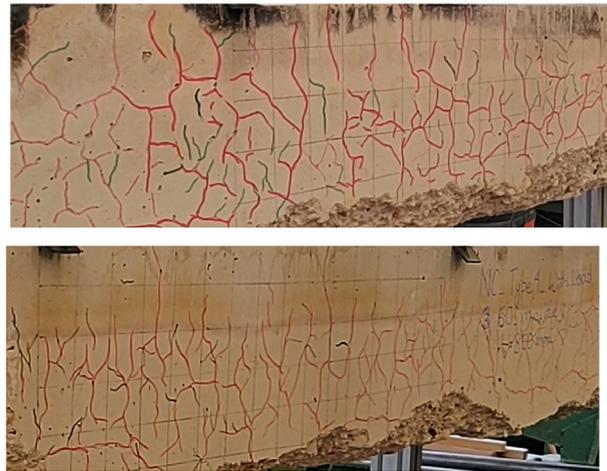
Fig. 3. a) Top view of the furnace, b) inside view of the furnace showing the exposed sides of the beams c) burners, d) view into the furnace during the fire test, e) post-heating thermal damage of the beams.

A large furnace (length 8 m x width 2.4 m x height 2.5 m) with the capacity of accommodating all the beams was used for the fire test. A total of twelve burners, six on the either side of the wall enable the thermal exposure of the standard time-temperature curve (ISO 834 [17]) inside the furnace. The furnace internal environment was monitored with twelve sheath thermocouples, placed through the furnace roof. The locations of the temperature thermocouples (S1 to S6 and W1 to W6) are illustrated in Fig. 3a. The beams were positioned on the furnace roof, keeping a space of minimum 0.6 m between them. The design of slab was such as to allow the heat exposure to three sides of the beam which includes bottom surface and two flank surfaces. The length of the beam exposed to the heat on all three sides was 2410 mm. The top surface of the beam (the surface towards the compression zone) was not exposed to fire and hence assumed to be insulated during fire exposure. All the specimens were tested unrestrained and without any external load applied on them.

After the beams were positioned in the furnace, the furnace was closed using reinforced aerated concrete slabs (Ytong Wandplatten P4.4/0.5 acc. to DIN 4223 [23]; length 625 mm, width 2800 mm, thickness 100 mm). The fire load was enforced by heating the furnace air temperature according to the standard ISO 834 curve for 1 h and subsequently cooled down to room temperature ($T = 20^\circ\text{C}$). The burners were shut down at the end of the heating phase and the ventilation ducts were slowly opened. Thereafter, the specimens were allowed to cool down naturally for at least 24 h. The furnace door was opened one day later.

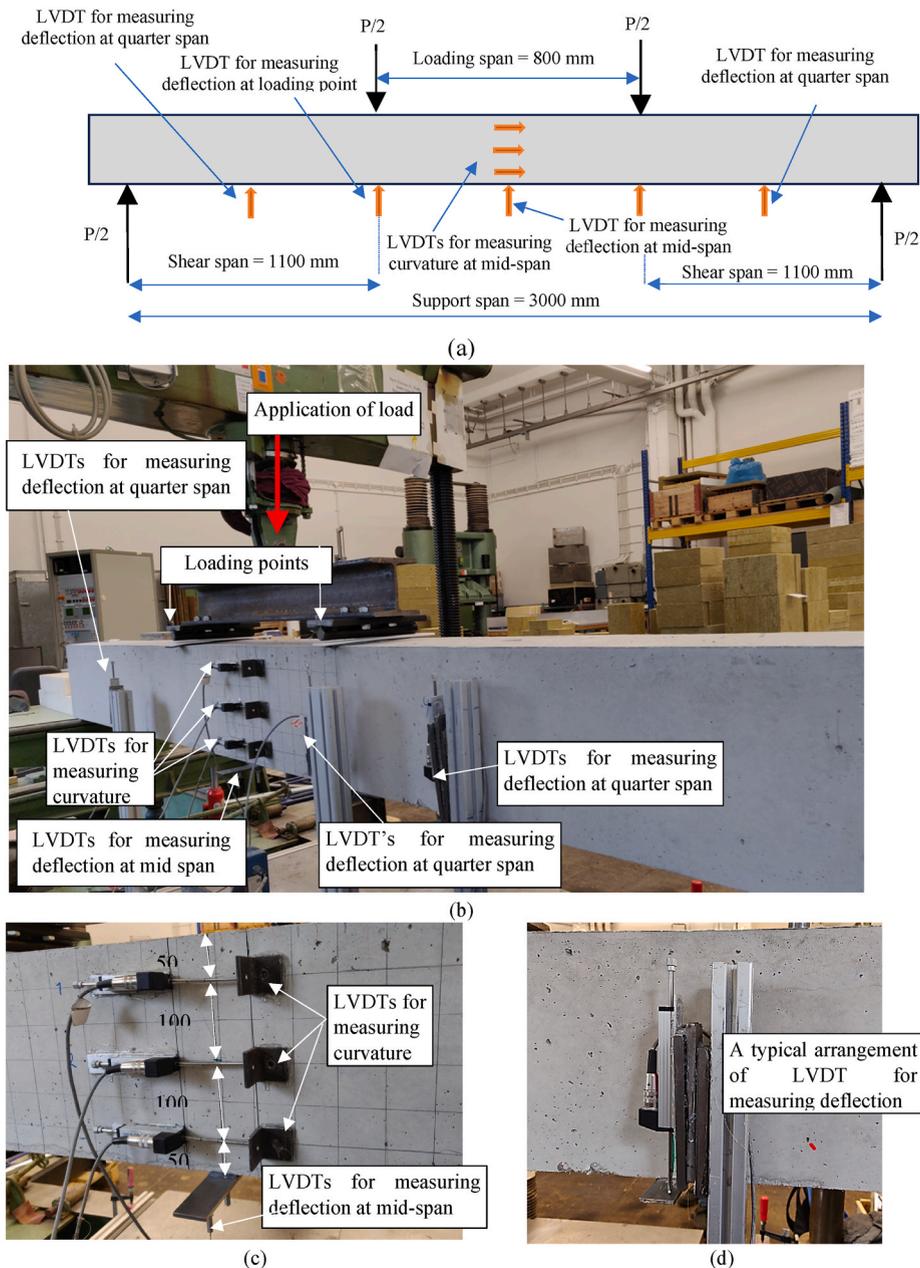
Fig. 4. a) Schematic diagram of the applied loading during the four-point bending test, b) a typical arrangement of the test setup c) placement of LVDTs at the mid span of the beam for measuring the curvature d) a close-up view of the LVDT for measuring the vertical deflection during the test.

All the beams were simply supported and loaded to failure in four-point bending under static load. The spacing of the supports was 3m. Fig. 4a presents a schematic diagram of the applied loading during the tests. The two-point load spaced symmetrically from the middle point of the specimen was applied to the beams by using the servo-hydraulic cylinder. The length of the uniform bending moment section, i.e. the loading points at the center of the beam was set to 800 mm irrespective of the presence and length of the lap splice giving a constant shear span of 1100 mm. During the tests the boundary conditions are considered in such a way so that the RC beams are simply supported with a roller support at one side and a hinged support at the other side. A steel spreader beam with two steel roller supports covering the entire width of the beam was used to distribute the load through two-point loads. The load was applied with constant force increment. A teflon sheet was sandwiched between the contact surfaces of the support with the uneven surfaces of the test beams to minimize friction. A calibrated load cell having a maximum load carrying capacity of 100 kN was placed between hydraulic jack and steel girder was connected to data logger to measure the force applied on the beam during the test.

Fig. 4b and c presents a close view of the LVDTs placed at different locations of the beam. A total of four LVDTs were mounted vertically at different locations of the bottom surface of the beam. Two of the LVDTs were placed at quarter-span on either side of the loading span, one the loading point and another at the mid span of the beam, with all four LVDTs placed at the bottom surface of the beam. The test setup was also equipped with three LVDTs placed horizontally at the mid span of the beam to measure the curvature.

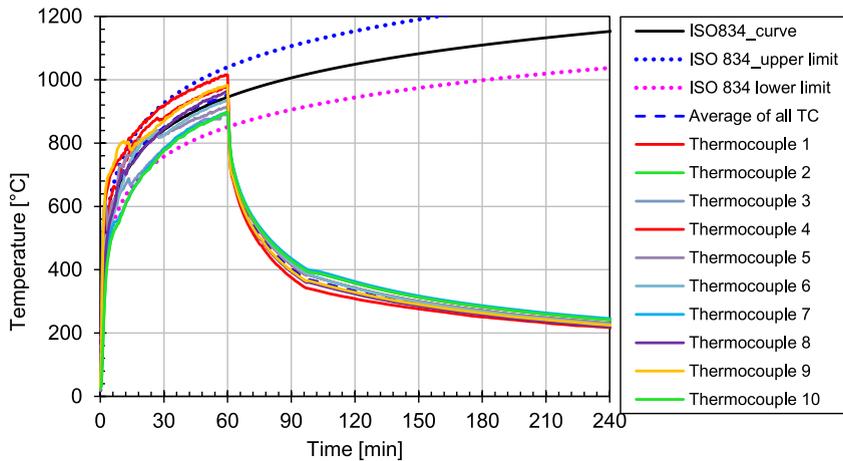
Fig. 5. Temperature inside the furnace during and after the fire test.

(ExtTC11-Ext_TC12) could not be recorded. Note that the graph “average” indicated the mean temperature measurements of the thermocouples within the furnace obtained from the fire tests. As can be seen, while the measured temperature in individual thermocouples slightly deviates from the target temperature, the average temperature profile nearly coincides with the standard fire curve. Upon reaching the target fire duration of 60 min, the burners were shut down and the ventilation ducts were opened, which lead to a rapid temperature drop within the furnace during the initial cooling phase. However, as the cooling phase progressed, the ventilation ducts were subsequently closed, resulting in a more gradual temperature decrease observed in the later stages.

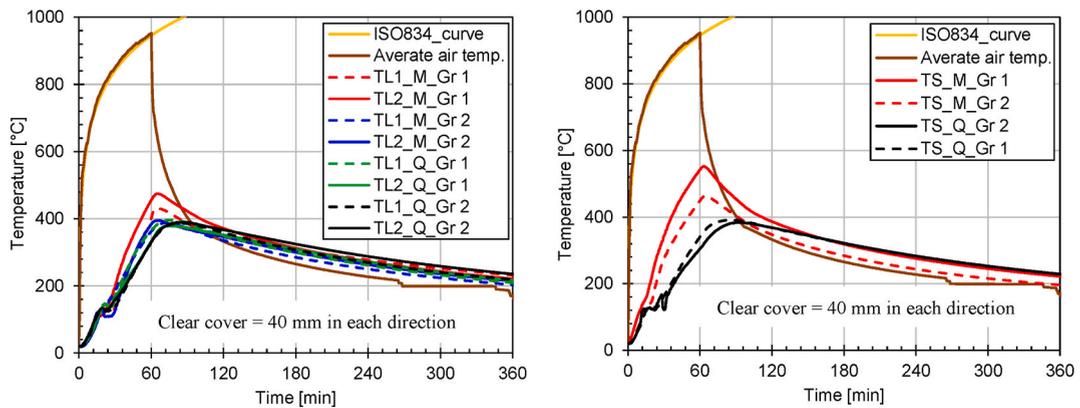
Fig. 6. Temperature measurements inside the concrete layers for 60 min of fire exposure duration a) rebar locations and b) stirrup locations.

Fig. 6a and b presents a comparison of the furnace temperature vs. time for the group 1 and group 2 beams. The oven temperature and the standard fire temperature are also shown in the same graphs. It should be noted that the “average” curve represents the mean temperature measurements of the thermocouples within the furnace recorded during the fire tests, as also shown in Fig. 5. On the left-hand side, the temperature measurements of the thermocouples placed on the top of the longitudinal rebars (TL) in the tension zone are plotted, whereas on the right-hand side the thermocouples were placed on the stirrup locations (TS). Expectedly, both beam types

exhibit very similar time-temperature curves for the entire heating and cooling phase. The global trend in both the cases reveals that the rate of temperature rise inside the concrete layers is much lower compared to the rise in furnace temperature irrespective of the location of thermocouples, which can be explained by the very low thermal conductivity and high thermal capacity of the concrete playing a crucial role to significantly slow down the heat penetration and to maintain lower temperatures within the inner layers of concrete. This results in a significant temperature gradient within the concrete layers, hence the outer layers try to expand due to heat (free thermal strain), while the inner (cooler) layers tend to restrain this expansion. This differential thermal expansion induces thermal stresses within the concrete, leading to the development of thermal cracks. Certain scatter can be observed in the temperature distribution within concrete, especially in case of thermocouples placed in the mid-span region. For example, the peak temperature of the thermocouple placed at the mid span of the longitudinal rebars of Group 1 beam is around 480 °C and the same is around 400 °C for the Group 2 beam. Similarly, the peak temperature of the thermocouple placed at the stirrups in the mid span region is around 540 °C, whereas the same is around 480 °C for the Group 2 beam. These differences in the temperature distribution inside the concrete layers

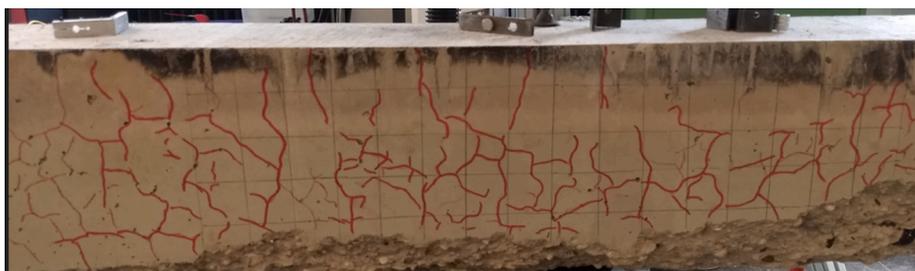
Fig. 7. Thermal cracks (marked in red) observed on the beam after the fire exposure.

Another important observation is thermal cracks on the fire exposed surfaces of the beams. Fig. 7 presents the thermal cracks marked on the beam surfaces. In order to identify and analysed the more significant thermal cracks only crack widths of 0.1 mm or greater are marked in this case. As mentioned above, the cool inside portion of concrete restrain the expansion of the heated surface. Moreover, high temperatures cause differential expansion between concrete and reinforcing steel. These effects lead to pronounced surface cracking.

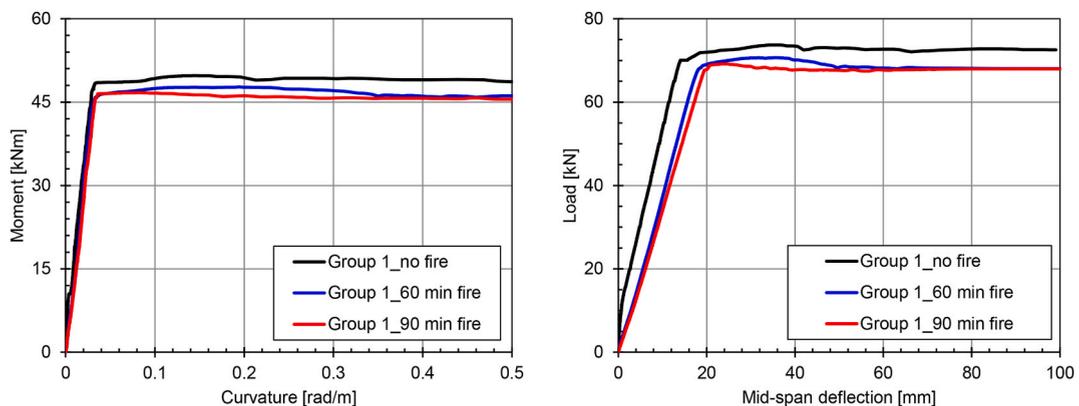
Fig. 8. Moment-curvature (left) and load-deflection (right) response of the Group 1 beams with and without fire exposure (Sharma et al. [13]).

When comparing the moment-curvature relationships between Group 1 (Fig. 8) and Group 2 beams (Fig. 14a), the principal difference lies in the overall response of the beams. Unlike Group 1 beams, the Group 2 beams exhibit a significant degradation of moment capacity in post-fire state due to fire exposure. This is attributed to the fact that in the case of Group 2 beams, the failure is controlled by bond splitting failure, which is governed by the tensile strength of concrete. Since concrete damage is aggravated due to exposure to fire and subsequent cooling, the fire-exposed beam is already subjected to damage in the critical lap splice region prior to mechanical loading and thereby results in reduced bending capacity.

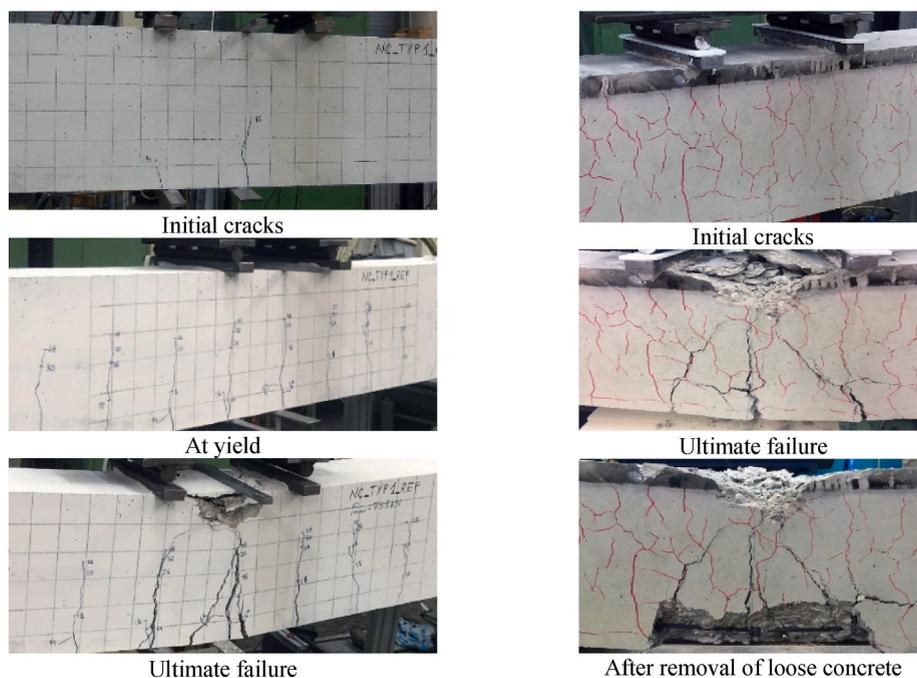
Fig. 9. a) Failure pattern of Group 1 beams: reference (no fire) specimen (left) and fire exposed specimen (right) (Sharma et al. [13]).

3.3.1.1. Failure mode. Fig. 9 illustrates the cracking pattern observed on the Group 1 beam without fire exposure (reference case) as well as fire exposed beams (60 min) [13]. As expected, due to the under-reinforced design and continuous reinforcement, the beams exhibited typical flexural behaviour for both the fire exposed and non-exposed cases, primarily governed by the yielding of the tensile reinforcement, resulting in large crack widths and plastic hinge formation in the mid-span of the beams. Prior to failure, several evenly spaced flexural cracks were observed along the span of the beams.

In case of the reference beam (no fire), initially, vertical flexural cracks appear in the region of maximum moment between the loading points. These cracks start at the tensile face of the beam and propagate upward toward the neutral axis. As the load increases, these cracks widen and extend further. With the further increase of the load, as the tension reinforcement yields, it allows for further deformation. Eventually, concrete in the compression zone reaches its ultimate strain capacity. When this limit is exceeded, the concrete in this region begins to crush locally on the beams top surface.

In the case of fire-exposed beams, vertical flexural cracks generally appear in the mid-span region between the loading points during the bending test, much like those observed in beams that had not been exposed to fire. However, those flexural cracks were primarily the pre-existing thermal cracks caused by fire exposure. Since they initiated during the heating and cooling phases, they continued to expand and propagate until yielding occurred. As with the beam that was not exposed to fire, concrete crushing in the compression zone was also observed.

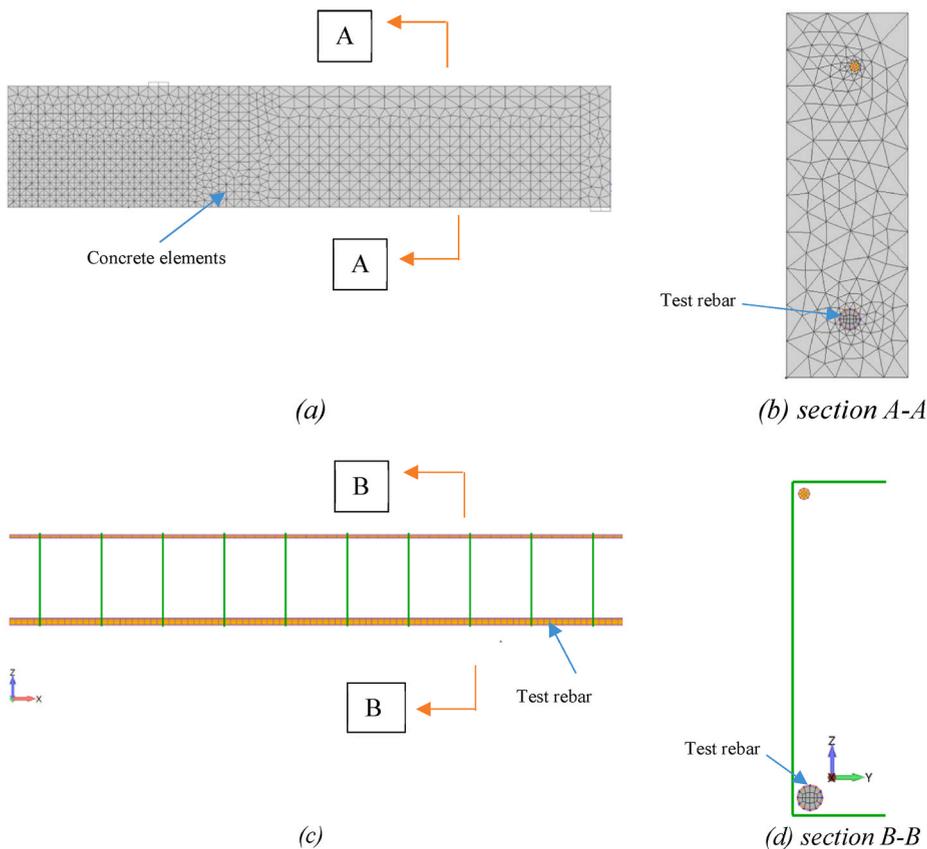
Fig. 10. Finite element model of the beam. a) Complete model of the beam b) Section A-A of the complete model c) Reinforcement-cage and d) Section B-B from the reinforcement cage.

To simulate the fire exposure scenario, the surface nodes of the finite element model were subjected to environmental (air) temperatures defined by the ISO 834 standard fire curve (ISO 834-1, 1999) [17]. The duration of fire exposure was varied from $t = 0$ to $t = 60$ min (reference specimens without fire) to the maximum exposure time considered. Consistent with the experimental program, heating was applied to three sides of the beam specimen—the top surface and the two vertical faces—while the remaining surface was left unexposed. In order to ensure direct comparability with the experimental results, the cooling phase recorded during testing was

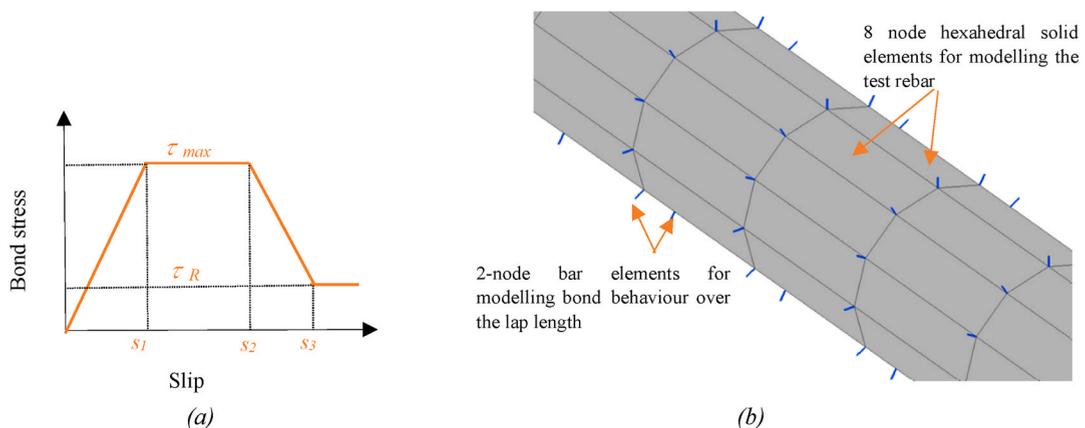
Fig. 11. a) Idealized bond stress–slip relationship used as constitutive law for the 2-node bar elements in the FE analysis. b) A closeup view of the test rebar along with the bond elements.

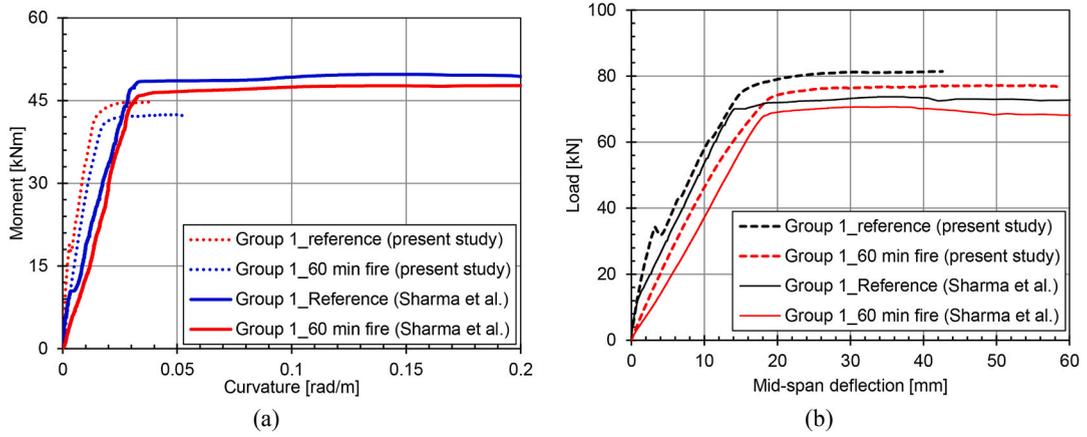
Fig. 12. A comparison of the numerical results of Group 1 beams obtained in this study with the one obtained by Sharma et al. [13]: moment-curvature (left) and load-deflection (right) response.

3.3.1.2.1. Numerical results. Fig. 12a presents a comparative assessment of the moment–curvature responses obtained from the present numerical simulations and those reported by Sharma et al. [13]. The comparison indicates that, while a slight variation exists in the ultimate moment capacity, the overall shape and progression of the curves show strong consistency. In particular, both studies capture the key stages of structural response, including the yielding of tensile reinforcement, and the subsequent strain-hardening behaviour prior to failure. Both the beams; the one subjected to fire exposure as well as the reference beam tested under ambient conditions, exhibited similar behaviour demonstrating that the numerical framework employed in this study is capable of reliably reproducing the fundamental flexural behaviour of continuous reinforced concrete beams. Similarly, Fig. 12b presents a comparative evaluation of the load–deflection responses obtained from the present numerical simulations and those reported by Sharma et al. [13]. The comparison reveals that, although a slight discrepancy exists in the ultimate load capacity, the overall trends of the two curves are highly consistent, capturing both the elastic and post-yield behaviour with good agreement. The minor variation in ultimate capacity can be reasonably attributed to differences in the distance between the applied loading points in the respective studies, which directly influences the shear span-to-depth ratio and, consequently, the ultimate load-capacity of the beams.

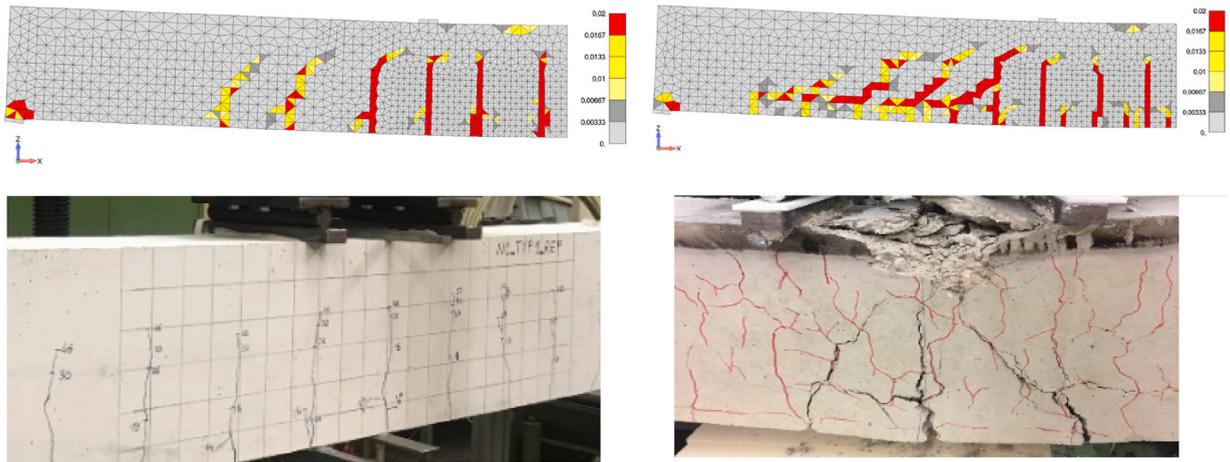
Fig. 13. A comparison of the numeral failure pattern and experimental failure pattern (Sharma et al. [13]) of Group 1 beams: reference (no fire) specimen (left) and fire exposed specimen (right) after ultimate load has reached.

3.3.1.2.2. Failure mode. Fig. 13 presents the cracking patterns obtained from the numerical simulations for both the Group 1 reference beam (unexposed to fire) and the corresponding beam subjected to 60 min of fire exposure. Consistent with the experimental observations reported in [13], the behaviour of these beams was governed by their under-reinforced design and continuous longitudinal reinforcement, which promoted a predominantly flexural response in both fire-exposed and unexposed conditions. In both cases, yielding of the tensile reinforcement controlled the structural response, leading to the development of wide cracks in the mid-span region. Once the rebar yields, the beam undergoes significant deflections, and the cracks in the tension zone continue to widen. As the load approached failure, multiple flexural cracks appeared along the span, distributed relatively uniformly, thereby reflecting the ductile nature of the response. Importantly, the numerical simulations successfully reproduced these features, including the sequence of crack formation, their spacing, and the ultimate flexural failure mechanism. This close correspondence with experimental results confirms the ability of the numerical model to accurately capture the post-fire flexural behaviour of RC beams and validates its reliability for further comparison and consideration of the results of the experimental investigations of Group 1 beams of

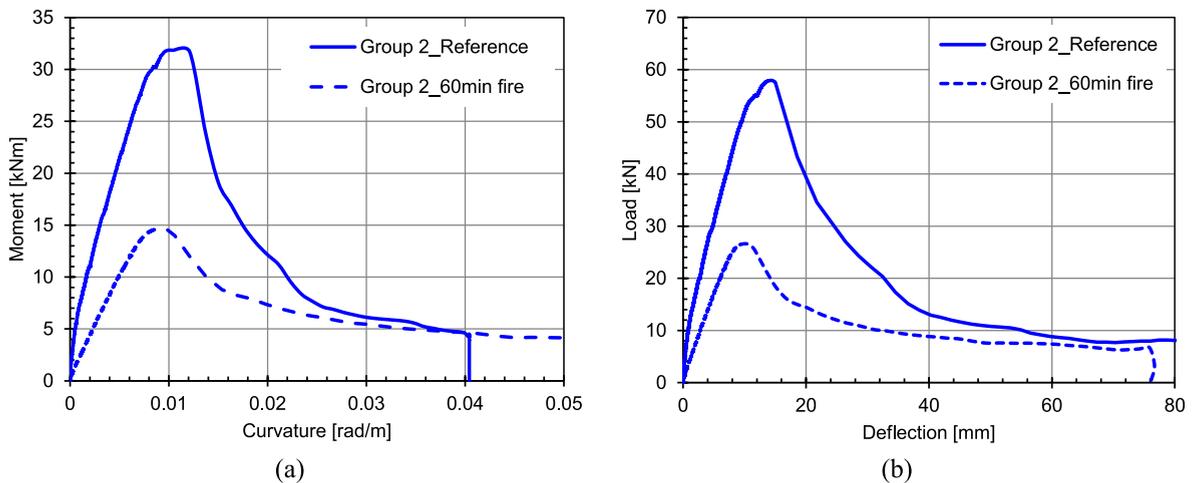
Fig. 14. Moment-curvature (left) and load-deflection (right) response of the (fire-exposed) Group 2 beams.

While analysing the moment-curvature behaviour of the reference beam, it can be observed that, at low loads, the moment-curvature curve follows a linear path, as both the concrete and reinforcement remained uncracked and elastic. No significant bond stress developed in the lap splice region yet and the beam behaves as expected under flexural loading. As the load increases, flexural cracks begin to form, particularly in the tension zone between the loading points. The moment-curvature curve became nonlinear as the concrete in the tension zone cracks and the load transfer relies more heavily on the bond between the spliced reinforcement and concrete. Before the reinforcement can yield, the bond between the concrete and the spliced rebar in the lap splice region fails. This bond splitting failure is marked by the appearance of longitudinal cracks along the axis of the tension reinforcement within the lap splice zone. As bond failure progresses, the beam loses its capacity to transfer stress from concrete to reinforcement. This leads to an abrupt post-peak decline in the moment–curvature response and a relatively brittle failure, with little warning prior to the ultimate failure.

The fire-exposed beam shows a similar moment-curvature behaviour. However, due to the impact of fire, the overall capacity is more than halved and the drop in the moment capacity in the descending branch is much more pronounced than in case of the reference beam. Moreover, the increase of curvature is much smaller as compared to the reference beam attributing to the already existing damage during the fire exposure.

To gain a deeper insight into the structural response, load displacement curves are also plotted (see Fig. 14b). In the initial stage, the beam exhibits an elastic response, where displacement increases proportionally with applied load. However, due to temperature-induced damage as well as material degradation, the stiffness of concrete is reduced compared to an unexposed beam. The weakened bond strength at the lap splice region results in premature bond-slip, causing a more gradual increase in load. Unlike unheated beams, no clear yield plateau is observed. After reaching the peak load, the curve immediately enters a steep descending phase, indicating brittle bond splitting failure rather than ductile behaviour. The rapid loss of load-carrying capacity is due to cracking in the concrete around the lap splice, followed by complete bond deterioration and reinforcement slip.

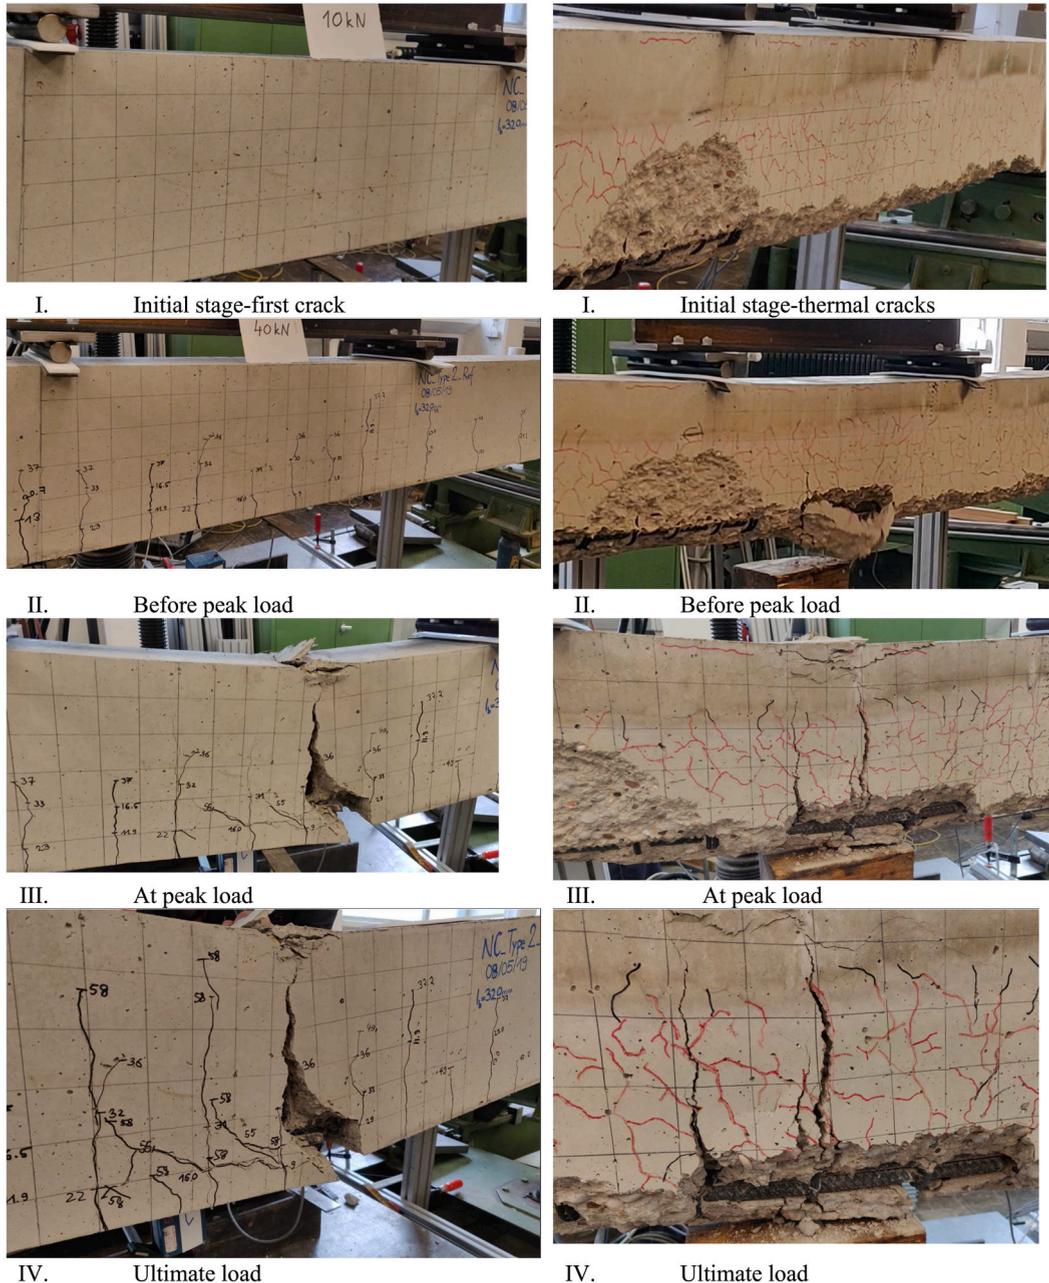
Fig. 15. Failure pattern of Group 2 beams a) reference specimen (left) and b) fire exposed specimen (right).

3.3.2.2. *Failure mode.* Fig. 15 presents the crack patterns obtained from the four-point bending test of Group 2 beams (reference beam and fire exposed beam) at different stages of the test, I) observation of the first crack, II) before the peak load, III) at the peak load and IV) at the ultimate load. The development of cracks at each stage of loading (every 10 kN) was monitored, marked, and measured on the beams until the load level at which new cracks did not occur. When comparing the failure mode of the reference beam without a splice (Group 1), the failure mode shifts from a ductile flexural failure in Group 1, driven by the yielding of the rebar in the tension zone, to a brittle failure in Group 2 beams, caused by bond splitting failure in the lap splice region. This change in failure mechanism was associated with the rapid loss of bond capacity, which prevented the effective transfer of stress between the overlapping rebars, thereby limiting the overall ductility and energy absorption capacity of the beams. It should also be emphasized that the bond failure observed in the Group 2 reference case was predominantly attributable to the insufficient lap splice length, which did not satisfy the minimum anchorage requirements prescribed by design standards, thus highlighting the critical role of adequate splice detailing in ensuring ductile behaviour and underscores the vulnerability of under-designed splice regions to brittle, bond-dominated failure modes.

Group 2 reference beam experienced initially typical bending cracks, similar to group 1 beam. Thereafter, vertical cracks formed at the end of the lap splice region in the tension zone of the beam which then propagated towards the top surface of the beam as depicted in Fig. 15(left). The bond failure was evident from the longitudinal crack running along the axis of the tension reinforcement within the lap splice region. Similar longitudinal cracks were also visible in the bottom side of the beam (not show in photos). In the final stage, concrete crushing in the compression zone was also evident on the top surface of the beam.

Similarly, when comparing the failure mode of the fire-exposed beam without a splice (Group 1), the failure mode once again transitions from a ductile flexural failure in Group 1 to a brittle failure in Group 2 beams, driven by bond failure in the lap splice region, same as the case of reference beam discussed above. However, fire has a significantly stronger impact on the lap spliced beam (group 2) leading to a more premature crack propagation and brittle crack pattern, with wider and more irregular cracks, especially concentrated in the splice area where the bond strength has been deeply compromised. Moreover, removal of cover concrete (bottom cover as well as side cover) around the splice even before reaching the peak load was also observed.

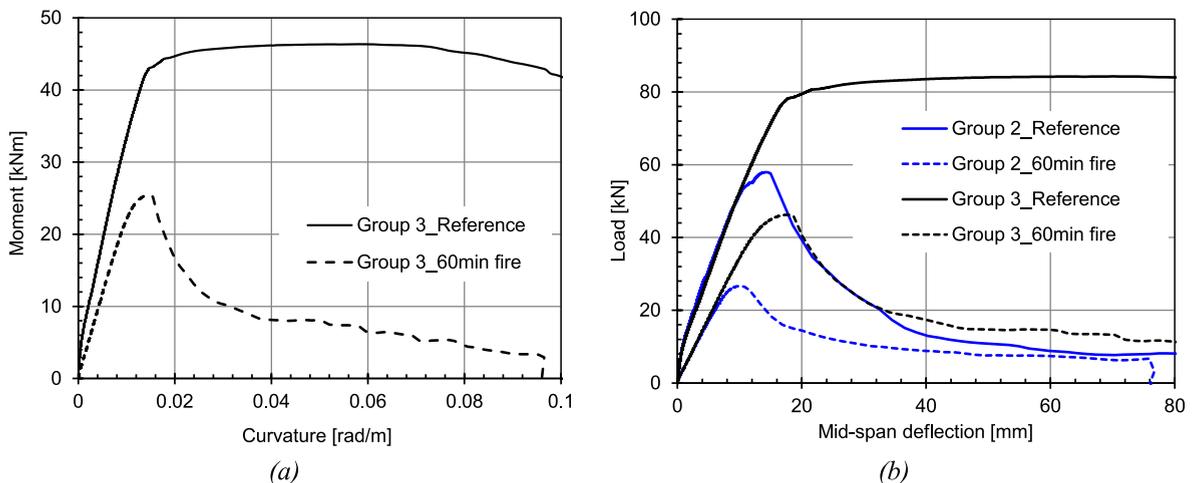
Fig. 16. a) Moment-curvature and b) load-deflection response (fire-exposed) of the Group 3 beams.

3.3.3.1. Moment-curvature. Fig. 16a presents the moment-curvature plot of the Group 3 beams both for ambient condition and fire exposed condition. Despite the larger splice lengths contributing to higher ultimate moment capacities in both the fire-exposed and unexposed beams compared to the Group 2 beams, the key observation remains the substantial reduction in capacity after fire exposure. Specifically, the ultimate moment capacity of the fire-exposed beam again saw a significant drop of about 50 % compared to the unexposed beam, highlighting again the detrimental impact of fire on the structural performance.

In contrast to the unexposed beam, where rebar yielded before failure thus allowing stress redistribution and progressive deformation, the fire-exposed beam showed a significant shift in behaviour. At the initial stage, the load-deflection curve begins with a linear relationship as the beam responds elastically. No significant deflection is observed, and the bond between the concrete and reinforcement remains intact initially. As the load increases, flexural cracks form in the tension zone, particularly near the lap splice region. The cracks initiate earlier than in the unexposed beam due to the thermally induced concrete damage. Curvature increases more rapidly as the cracks propagate. Instead of yielding of the rebar, the bond between the concrete and reinforcement in the lap splice zone fails prematurely due to the compromised bond strength from fire exposure. This results in a sudden loss of load-carrying capacity and a brittle failure, thus severely reducing the moment capacity of the beam. This emphasizes the detrimental impact of fire on both strength and failure characteristics of reinforced concrete. Additionally, the similarity to the Group 2 beam behaviour suggests that even a splice length increase to $15d_s$ is insufficient to achieve ductile failure after a fire exposure duration of 1 h. However, as the splice length is greater in beams of Group 3 compared to the Group 2 beams, the former display higher moment capacity and initial stiffness.

The load-displacement curve of a Group 3 beam (see Fig. 16b) exhibits a behaviour similar to that of Group 2 beams, with some notable differences. It is visible from the curves that the reference group 3 beam exhibits ductile failure whereas reference group 2 beam exhibits bond splitting. After exposure to fire, both beam types exhibit bond failure.

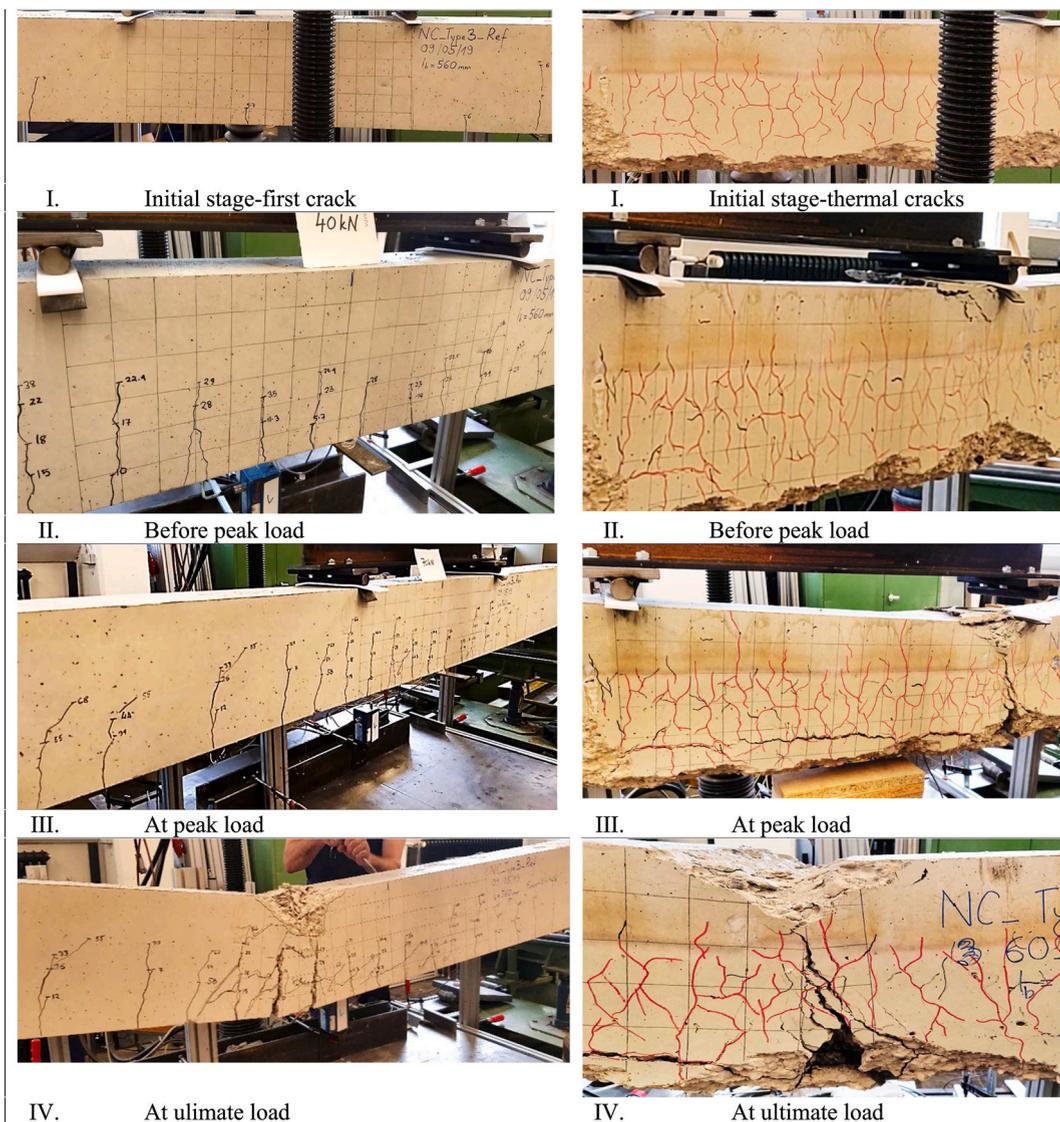
Fig. 17. Failure pattern of Group 3 beams a) reference specimen (left) and b) fire exposed specimen (right).

3.3.3.2. Failure mode. Fig. 17 presents the crack patterns obtained from the four-point bending test of Group 3 beams (reference beam and fire exposed beam) at different stages of the tests. When comparing the failure mode of the reference beam of the Group 2, the failure mode shifts from a brittle failure in Group 2, driven by the bond failure in the lap splice region, to a ductile failure in Group 3 beams, caused by yielding of the rebar in the tension zone.

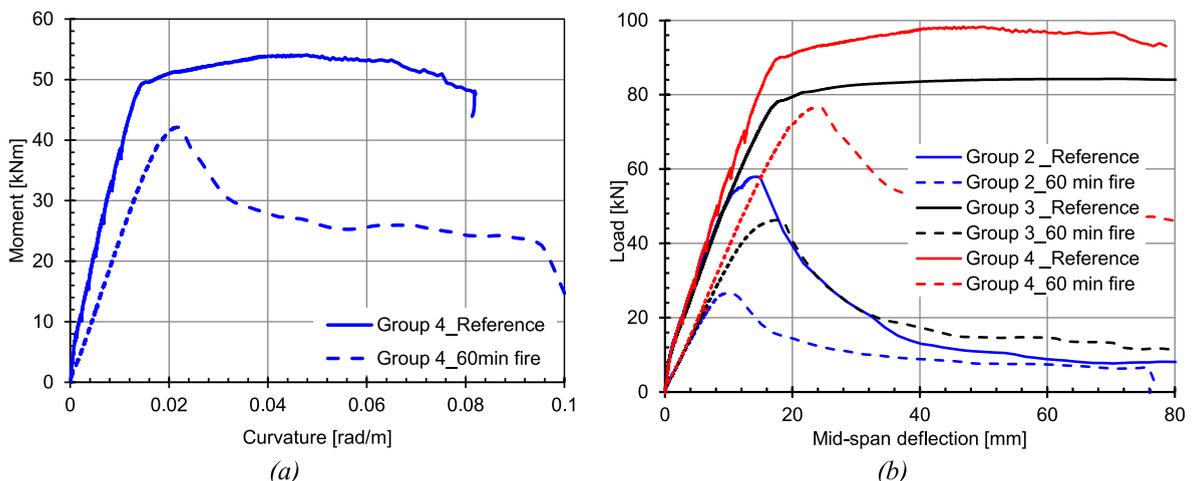
Fig. 18. a) Moment-curvature and b) load-deflection response (fire-exposed) of the Group 4 beams.

As previously discussed in the moment-curvature response, the load-displacement curve (see Fig. 18b) of a Group 4 beam exposed to fire exhibits notable enhancements in load-bearing capacity and stiffness, outperforming other fire-exposed beams. The ascending portion of the curve exhibits a steeper slope, reflecting the slightly higher initial stiffness due to the extended lap length, which enhances load transfer between spliced bars. The load increases steadily, reaching a peak almost equal to the reference beam before failure mechanisms initiate. Following the peak load, the curve shows a sudden drop, indicating bond splitting failure and the onset of rebar slip. However, unlike Group 3 beams, the residual load capacity in the post-peak region is significantly higher, which indicates that the beam can still sustain a considerable portion of the load before complete failure.

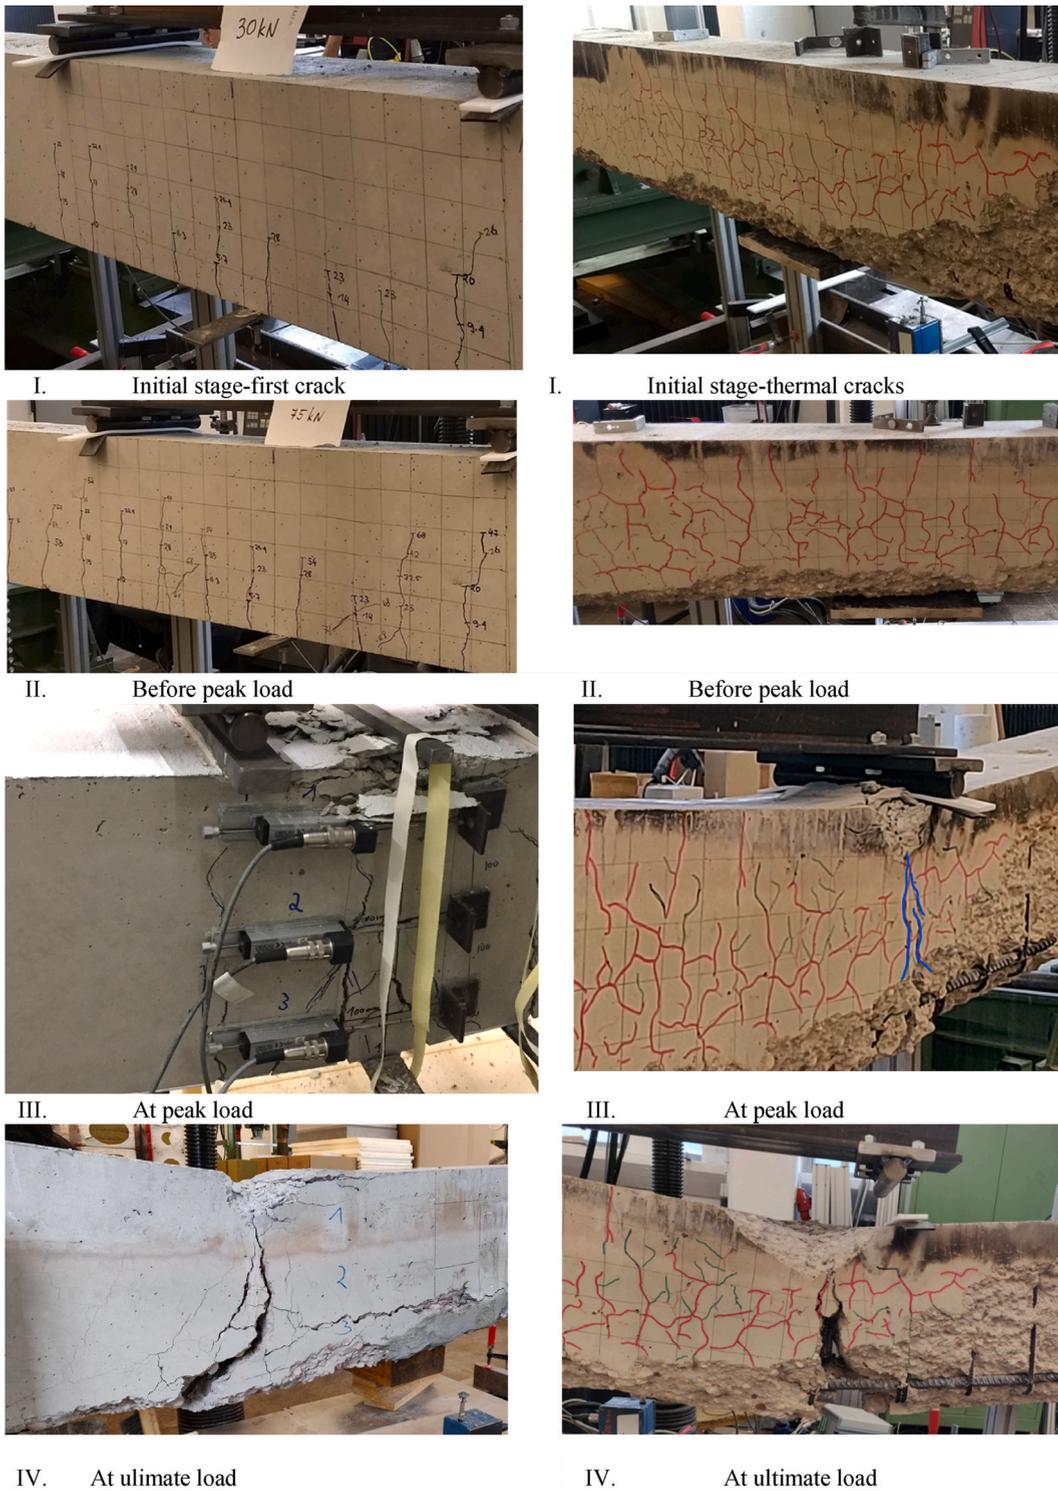
Fig. 19. Failure pattern of Group 4 beams a) reference specimen and b) fire exposed specimen.

3.3.4.2. Failure mode. Fig. 19 presents the step-by-step photos of failure obtained from the four-point bending test. Similar to the beams of other group, the thermal cracks visible on the surfaces obtained from the fire tests are marked prior to the machinal loading test. As all the beams were exposed to fire for the same duration, the obtained thermal cracks are very similar as observed in other

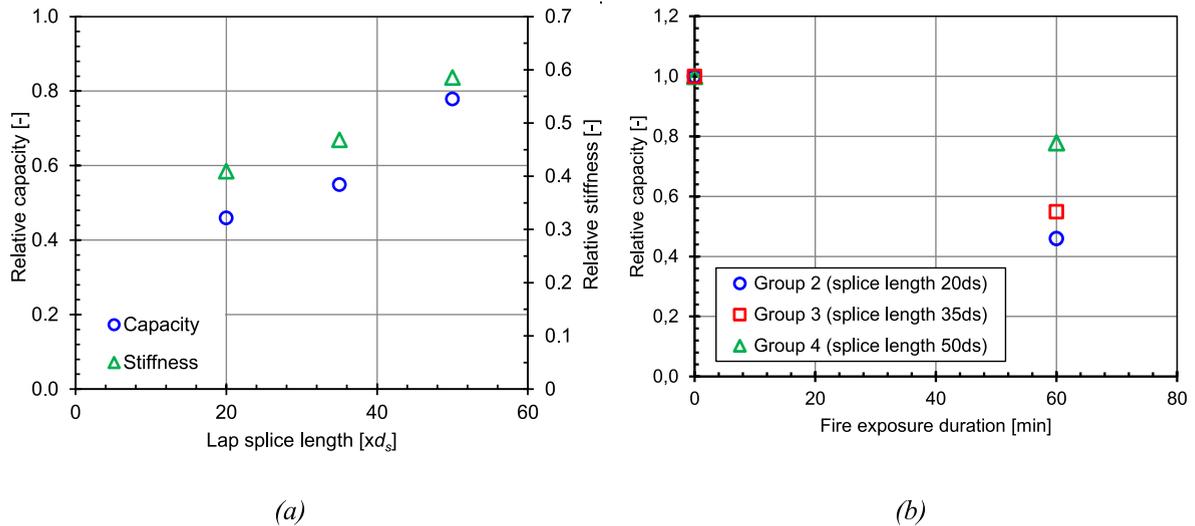
Fig. 20. a) Relative post-fire capacity and stiffness as a function of lap-splice length of all investigated beam groups and b) Relative post-fire capacity as a function of fire exposure duration.

Fig. 20a presents relative capacity as a function of lap splice length, with relative stiffness also plotted for a comprehensive understanding of structural behaviour. To enhance clarity, relative stiffness is displayed on the secondary y-axis, allowing for a distinct representation of both parameters and their interdependence. Fig. 20b presents relative capacity as a function of fire exposure

durations. The data illustrates a clear trend where both relative capacity and relative stiffness increase with an extension of the lap splice length, emphasizing the crucial role of sufficient splice length in maintaining the structural integrity of reinforced concrete (RC) members. As can be observed, group 1 beams retained 46 % of their post-fire capacity, Group 2 beams retained 55 %, and Group 3 beams retained 78 %.
