Journal of Building Engineering

Experimental investigations on the bond performance of reinforced concrete beam with lap splices after fire exposure

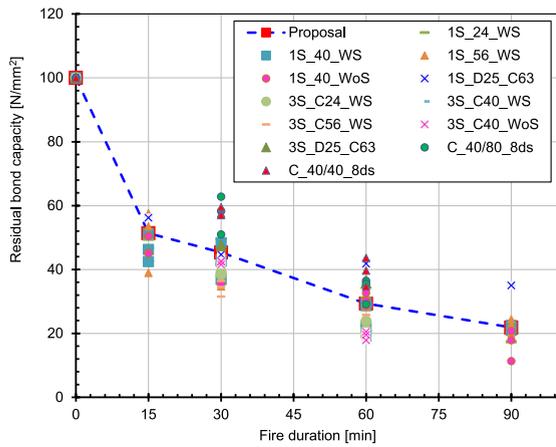
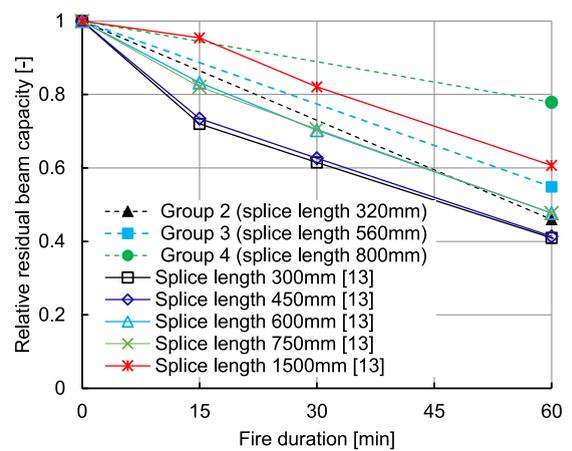
Fig. 21. a) Relative residual bond capacity as a function of fire exposure durations for all the investigated specimen considering beam-end specimen (Das et al.) [3] (left) b) Relative bond strength of lap splices with different splice lengths (taken from Tonidis et al. [14](right).

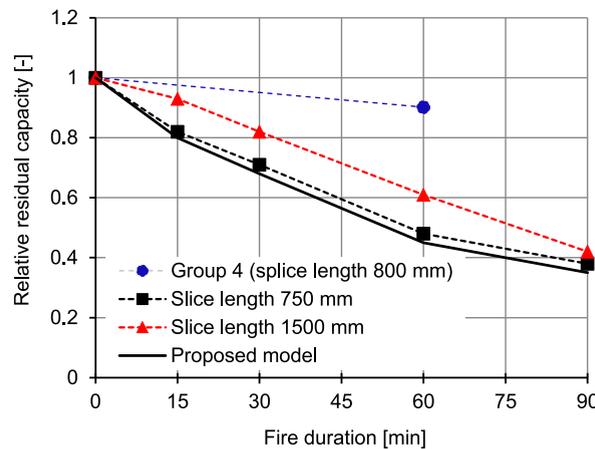
Fig. 22. Relative residual capacity as a function of fire duration for different values of the lap length (partly taken from Tonidis et al. [14].
