## Journal of Building Engineering

# Mechanical and chemical effects of wet-dry cycling and UV exposure on flax textile reinforced recycled aggregate concrete: role of rice husk ash

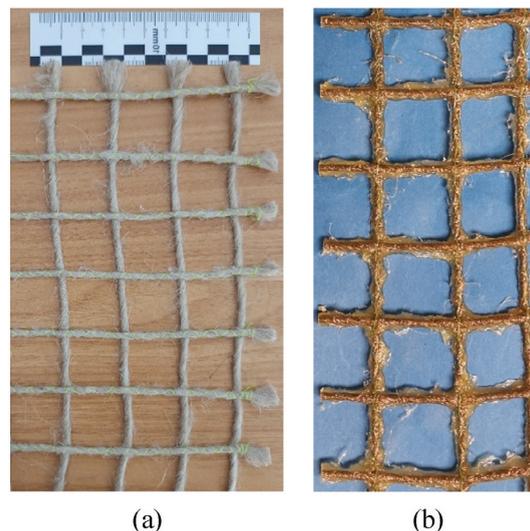
Fig. 1. (a) Flax textile and (b) FFRP.

in Fig. 1 (b)) were cut into 400 mm rods for weathering exposure and 500 mm × 100 mm strips for the fabrication of reinforced RAC.

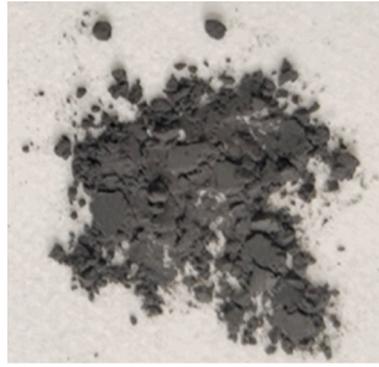
Fig. 2. Rice husk ash after re-burning and grinding [9].

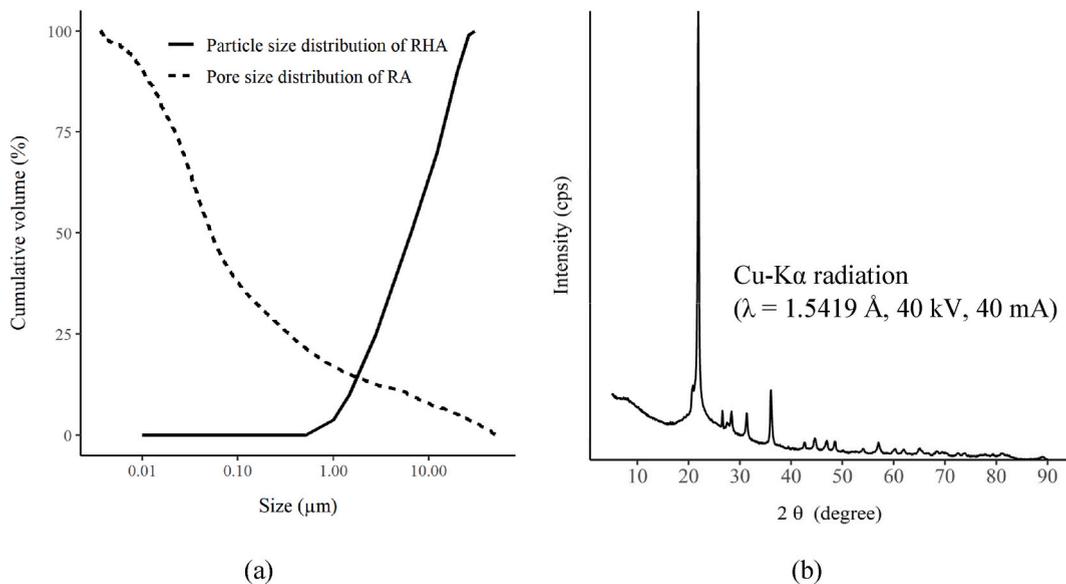
Fig. 3. (a) Particle size distribution of RHA and pore size distribution of RA, (b) the crystalline phase of the RHA from XRD [9].

Rice husk ash (RHA), obtained from a power plant in Lingshou County, China, was used as a supplementary cementitious material. The ash was re-calcined at 600 °C for 3 h and ground at 320 rpm for 30 min using a planetary ball mill. Fig. 2 presents the RHA after pre-treatment. This treatment yielded RHA with a silica content above 90 % (Table 1), a loss on ignition of 2.8 %, and a mean particle size of 9.27 µm. Particle size analysis (Fig. 3 (a)) showed that 50 % of the particles were below 6.48 µm, all under 30 µm. The X-ray diffraction (XRD) pattern (Fig. 3 (b)) confirmed the presence of crystalline silica.

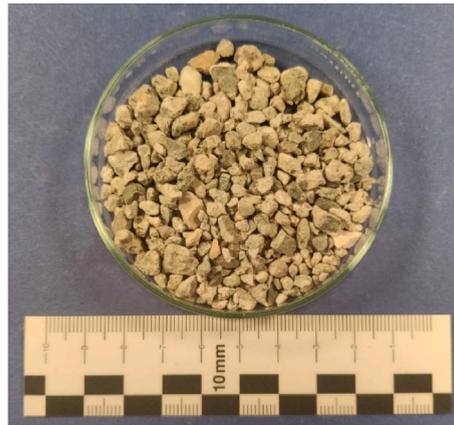
Fig. 4. Recycled aggregates.

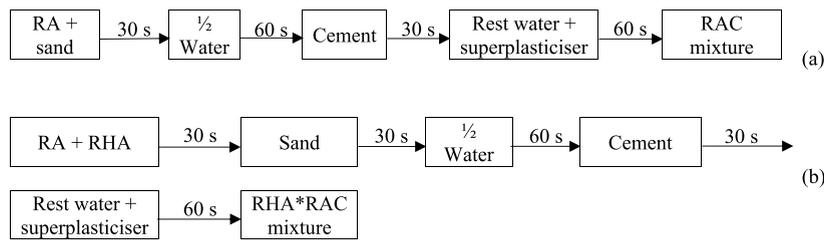
Fig. 5. Mixing procedures for (a) RAC and (b) RHA\*RAC [9].

The concretes used in this study consisted of RAC and a modified version incorporating RHA as a supplementary cementitious material (RHA\*RAC). Both mixtures were prepared in accordance with the mix proportions established in our previous research [9, 10], as detailed in Table 2. In the RHA\*RAC, RHA was incorporated as a supplementary cementitious material at a 10 % replacement ratio by weight of the total binder. This proportion was selected based on findings from previous studies [37–40], which identified 10 wt% as the optimal substitution level for cement for enhancing the compressive properties and long-term durability of RAC. Due to the high water absorption of the recycled aggregates (4.58 % [9]), additional water was added to ensure adequate workability of the concrete paste. The required amount was calculated by subtracting the measured moisture content (0.78 %) from the absorption capacity, resulting in 3.8 % extra water relative to the RA weight. A two-stage mixing procedure, as described in Ref. [41], was used to prepare both RAC and RHA\*RAC pastes (see Fig. 5). For each 500 mm × 100 mm × 15 mm reinforced panel, a single layer of FFRP reinforcement was embedded at mid-depth, with a reinforcement ratio of approximately 1.2 % along the loading direction. The casting process followed the method previously detailed in our earlier studies [9,10]. After 28 days of curing, the panels were transferred to a weathering chamber. Additionally, Ø100 mm × 200 mm cylindrical specimens were cast using identical mix designs and procedures, and were also placed into the weathering environment.

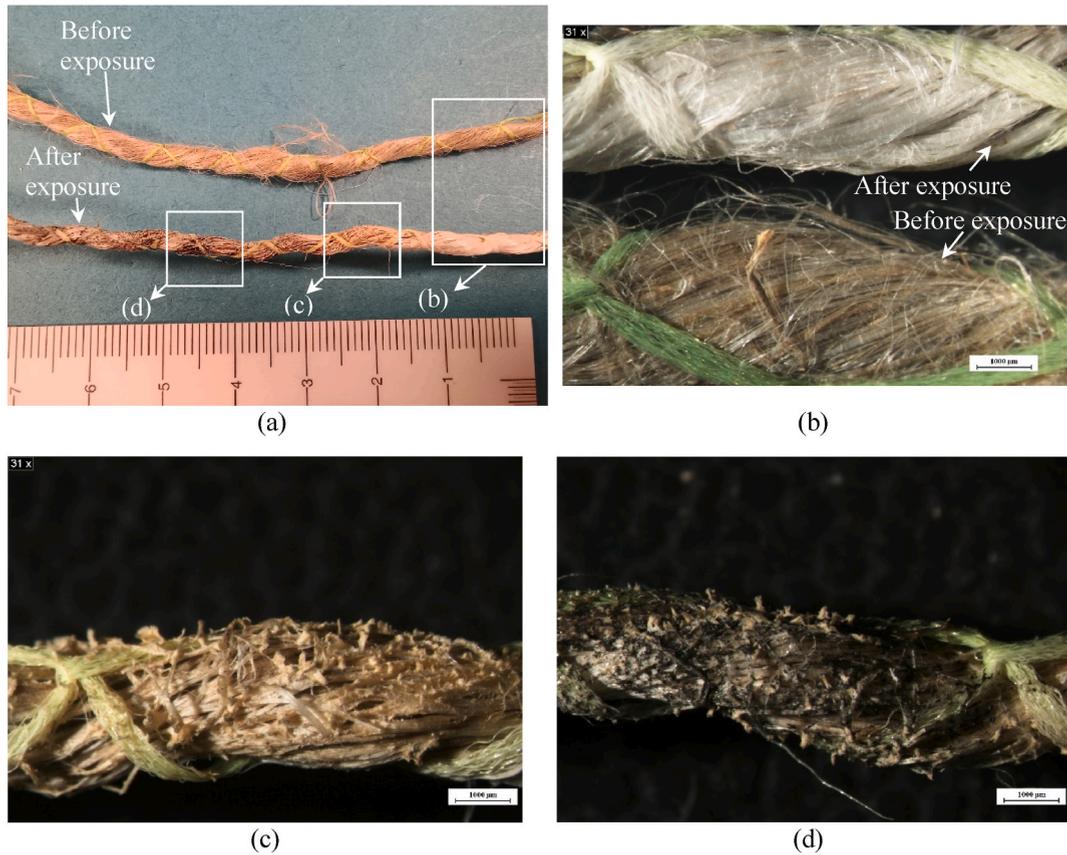
Fig. 6. (a) Comparison of the overall morphology of flax yarns before and after exposure, (b) discoloration of the exposed flax yarn compared with the yarn before exposure, (c) fibre fibrillation and (d) fibre fibrillation along with surface darkening observed on the exposed flax yarn.

The flax yarn subjected to the weathering condition exhibited various morphological changes. Fig. 6 (a) provides an overview of the exposed flax yarn, while the typical morphological alterations observed under an optical microscope are shown in Fig. 6(b)–(d). Discolouration is one of the most visible consequences of exposing lignocellulosic fibres to UV irradiation, primarily driven by the photo-degradation of lignin and the oxidation and hydrolysis of cellulose [18]. Fig. 6 (b) shows the discolouration of the flax yarn after 30-week exposure, showcasing a significant transformation compared to the original yarn. The flax fibres exhibited whitening and transparent as a result of the prolonged combined effects of UV irradiation and wet-dry cycles. The wet-dry cycling likely exacerbated the discoloration phenomena. Repeated swelling and shrinking exposed internal lignin and cellulose to UV light, accelerating both photo-degradation and photo-oxidation. The degradation of lignin and pigments produced water-soluble compounds, which were readily leached out during water spraying, further enhancing the whitening effect. Additionally, these processes may have induced changes in the fibre structure, such as increasing fibre crystallinity. This structural reorganisation likely contributed to the observed transparency of the flax fibres. Fig. 6 (c) illustrates a rougher surface of the flax yarn after exposure. Both UV irradiation and wet-dry cycling can contribute to surface erosion of lignocellulosic fibres [18,20]. This process weakens the fibre's structural integrity, leading to the microcracking and the splitting of microfibrils. Over time, these structural changes manifest as fibre fibrillation, where individual fibrils detach from the main fibre, creating a rougher surface and further compromising the mechanical properties. Fig. 6 (d) showed the fibre fibrillation along with the darkened appearance of the yarn's surface. During the UV irradiation, lignocellulosic fibres undergo different various degrees of discolouration, with darkening and yellowing being the most common effects. These colour changes are primarily due to the formation and accumulation of chromophoric compounds resulting from the degradation of lignin. In the case of Fig. 6 (d), the chromophores produced during UV exposure adhered to the fibre surface. Despite the wet-dry cycling, these

Flax fibres extracted from various sections of the exposed yarn, as shown in Fig. 6, were analysed using Fourier-transform infrared (FTIR) spectroscopy. Their spectra were then compared with those of fibres from the original, unexposed yarn. To eliminate the intensity variations caused by factors such as sample thickness, sample concentration and path length during measurements, all spectra were normalised to ensure that the analysis focuses on relative differences in the chemical composition or structural changes. The normalisation was conducted based on the absorbance at  $1030 \text{ cm}^{-1}$ , with its intensity set to 1 [49–52]. The normalised FTIR spectra

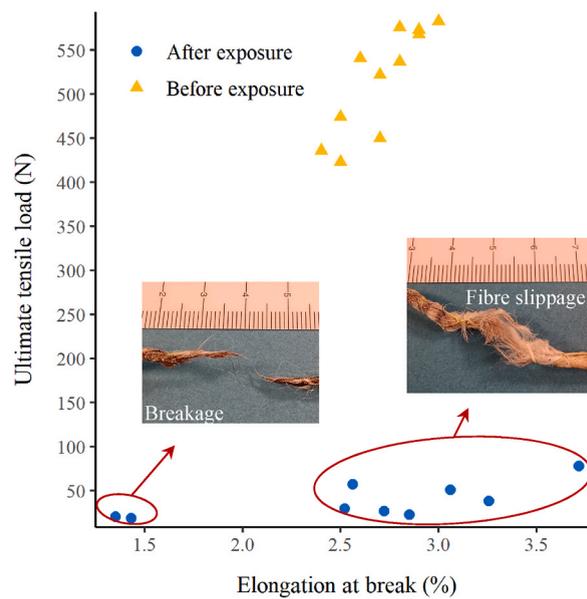
Fig. 7. Tensile properties of flax yarns before and after exposure.

The flax yarn experienced substantial reduction in tensile load capacity after weathering exposure, which is evident in Fig. 7. The average ultimate tensile load of the exposed yarns is only 7.4 % of the original average value. Fig. 7 shows the corresponding failure modes. Only two of the exposed yarns failed in breakage under tensile load, whereas the majority failed due to fibre slippage. The two samples that failed due to breakage both fractured at the blackened sections of the yarns, where fibre fibrillation was also observed. These two broken yarns exhibited remarkably decreased elongation, indicating the increased brittleness at these sections of the yarn, as mentioned in Section 3.1.1. This brittleness primarily resulted from lignin degradation and fibre fibrillation. Moreover, the splitting of microfibrils caused fibrillation. This process compromised the mechanical integrity of the yarn and resulted in a significant reduction in strength. Yarn untwisting and the subsequent fibre slippage occurred more frequently when the exposed yarns were subjected to tensile stress. It was visible that, at certain positions along the yarn, particularly in areas with whitening discoloration but no fibre fibrillation, the external fibres aligned nearly parallel prior to tensile testing. The absence of cohesion forces among the fibres rendered them prone to slippage under tensile stress. The measured yarn elongation reflected the slip displacement occurring between fibres, resulting in elongation values higher than those of the broken yarns. The yarn untwisting was mainly attributed to the wet-dry cycling, during which the repetitive swelling gradually relaxed the internal stresses within the yarn, destabilising the twisted configuration and promoting untwisting. This can also be verified by the fact that untwisting typically happened in regions where leaching was concentrated. The varied failure modes of the exposed yarns resulted in more scattered elongation measurements and also increased the coefficient of variation of the ultimate tensile load to 4.5 times its original value. The load-bearing capacity of exposed yarns that failed by breakage was generally lower than that of yarns that failed due to fibre slippage. This can be attributed to the fact that fracture consistently occurred in the blackened regions of the yarns, where extensive photo-degradation and fibrillation were observed. As evidenced by the FTIR analysis presented in Section 3.1.3, these regions exhibited a significant reduction in both cellulose content and crystallinity. Consequently, the tensile strength of the flax fibres in these areas was markedly diminished, falling below the frictional resistance required for fibre slippage. Furthermore, among yarns that failed via slippage, the degree of untwisting varied considerably. This led to a heterogeneous distribution of cohesive and frictional forces among the constituent fibres, manifesting as a broad dispersion in ultimate tensile load values. To summarise, the primary impact of wet-dry-UV irradiation cyclic exposure on the mechanical structure of flax yarn were untwisting, increased brittleness, and, as a result, a significant reduction in tensile strength.

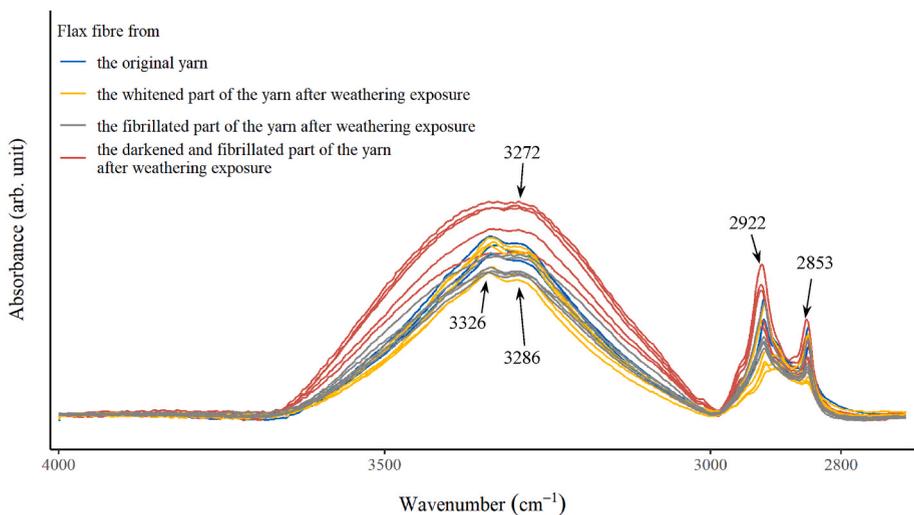
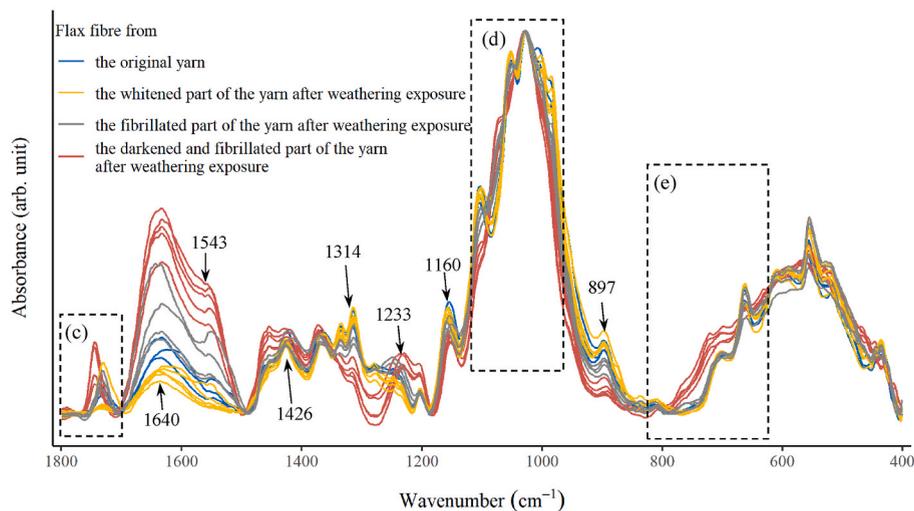
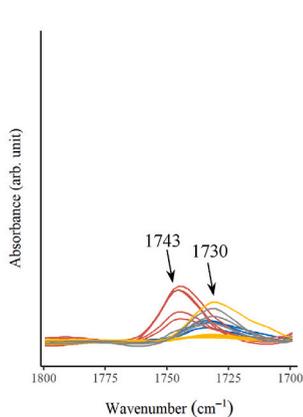
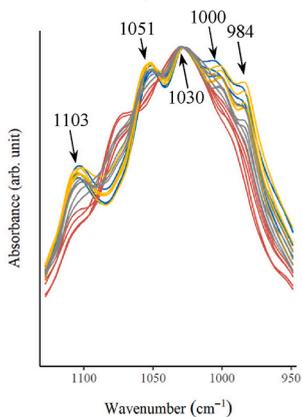
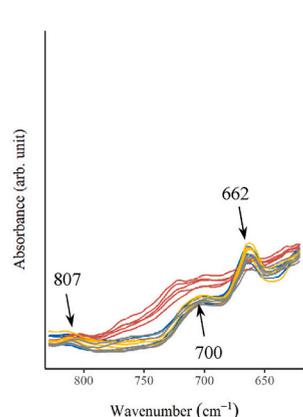
**Fig. 8.** Normalised FTIR spectra of flax fibres from the yarn before and after exposure: (a) 4000–2700  $\text{cm}^{-1}$ , (b) 1800–400  $\text{cm}^{-1}$ , (c) 1800–1700  $\text{cm}^{-1}$ , (d) 1130–950  $\text{cm}^{-1}$  and (e) 830–620  $\text{cm}^{-1}$ .

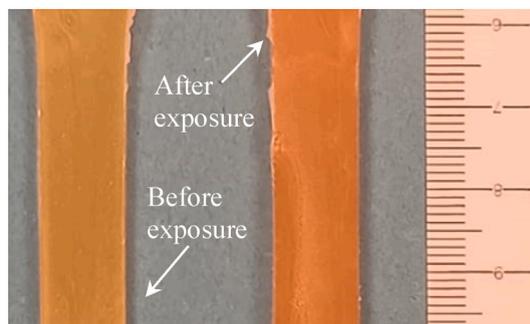
Fig. 9. Yellowing of epoxy after weathering exposure.

Fig. 9 shows the yellowing of epoxy after the exposure, which is typically due to UV-induced photo-degradation. The photo-oxidation primarily affects the bisphenol A-derived structures and the aliphatic portions of the epoxy network. This process leads to the formation of carbonyl groups, which are common chromophores and play a key role in the characteristic yellowing observed after prolonged UV exposure [21].

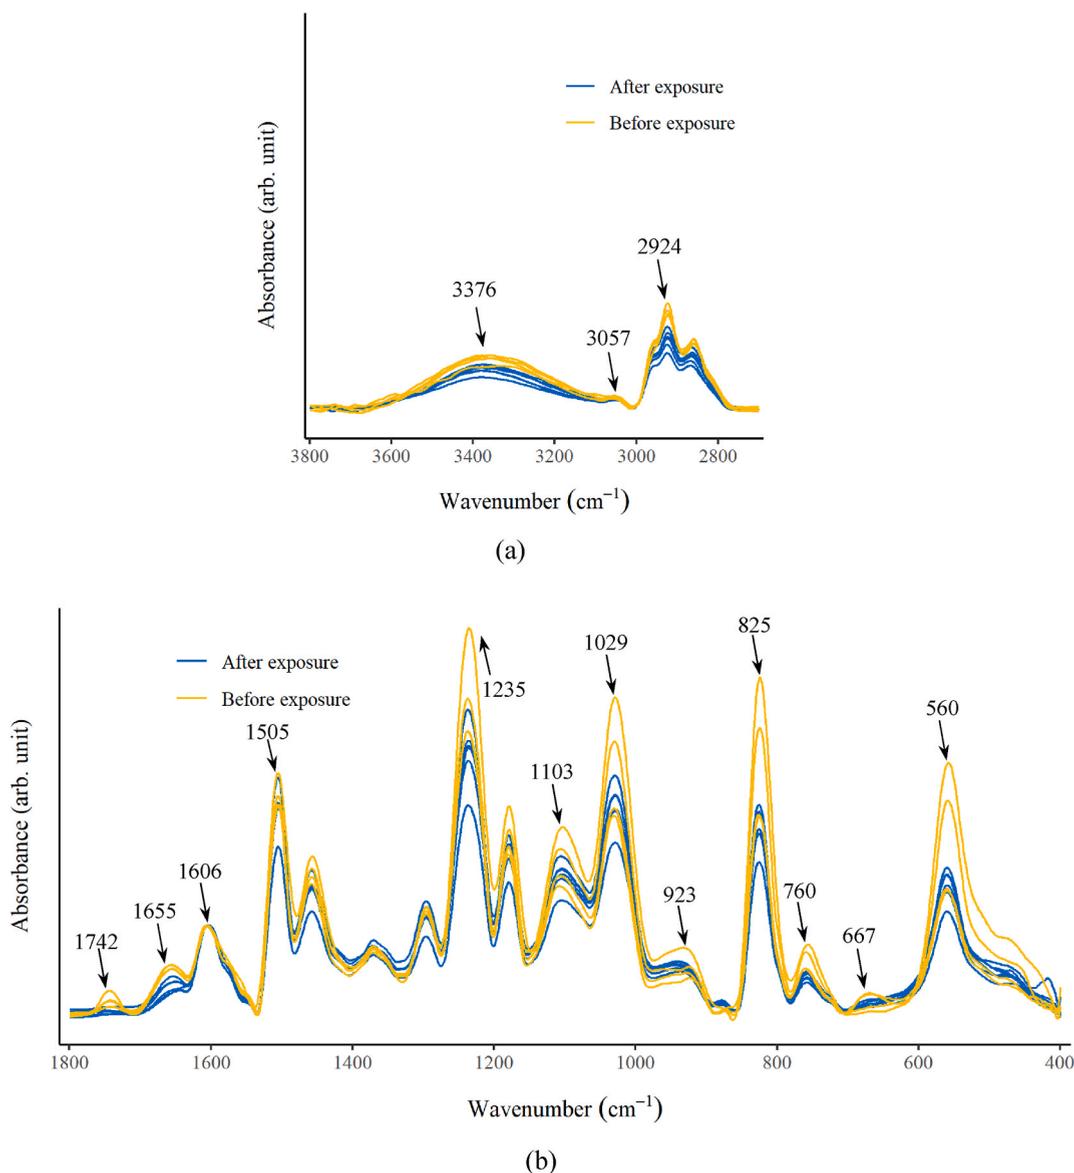
**Fig. 10.** Normalised FTIR spectra of the epoxy samples before and after exposure: (a) 3800–2700  $\text{cm}^{-1}$  and (b) 1800–400  $\text{cm}^{-1}$ .

Fig. 10 presents the FTIR spectra of the epoxy samples before and after exposure. The spectra were normalised to the intensity of the band at  $1606\text{ cm}^{-1}$ , assigned to C=C stretching in aromatic rings, which remains relatively stable under UV exposure [22,69]. The assignments of the corresponding vibrations are provided in Table 6, and the integrated intensities of these vibrations were also calculated. The *t*-test revealed significant reductions in the integrated intensity of the exposed epoxy at  $3376$ ,  $3000\text{--}2750$ ,  $1742$ , and  $1655\text{ cm}^{-1}$ , compared to the original epoxy (all adjusted p-values  $<0.05$ ), as highlighted in red in Table 6. It suggests that weathering exposure, primarily UV irradiation, caused significant degradation of the amine groups/hydrogen bonds as well as the aliphatic portions, aldehyde and amide groups in the cured epoxy. Among these, the aldehyde group, present in the original epoxy samples and identified at  $1742\text{ cm}^{-1}$ , originates from the formaldehyde included in the Ampreg 31 resin mixture [34]. Formaldehyde undergoes degradation when exposed to UV irradiation and is ultimately oxidised into  $\text{H}_2\text{O}$  and carbon dioxide  $\text{CO}_2$  [70–72]. Amin et al. [73] reported that the photolysis process achieved approximately 46 % efficiency in the removal of formaldehyde within 60 min. The photolysis degradation of formaldehyde led to nearly zero integrated intensity of the band at  $1742\text{ cm}^{-1}$  for the epoxy sample after exposure. Additionally, the significant reduction in the integrated intensity in the  $3000\text{--}2750\text{ cm}^{-1}$  region supports the previous statement that photo-oxidation primarily targets the aliphatic portions of the epoxy network. Indeed, the decrease of the integrated intensity at  $760\text{ cm}^{-1}$  is also significant at the  $\alpha = 0.1$  level (adjusted p-value = 0.0824). This band attributes to the C-H out-of-plane

bending of aromatic ring [74–76], indicating that the photo-oxidation also had a notable effect on the bisphenol A-derived structures. The photo-oxidation product carbonyl groups are common chromophores leading to yellowing of epoxy after UV irradiation, typically showing the vibration at 1730–1750  $\text{cm}^{-1}$  [69,77]. However, no evident peak is observed in this carbonyl region of the spectra for the exposed epoxy in Fig. 10 (b). This absence could be attributed to the limited formation of chromophores, as there was minimal discoloration observed, as shown in Fig. 9. Moreover, the vibration at 1655  $\text{cm}^{-1}$  corresponds to the amide groups [74,78,79], which are the crosslinks formed by amine group from the hardener with oxirane group from the resin (this reaction may also involve formaldehyde). The significant reduction in integrated intensity at 1655  $\text{cm}^{-1}$  suggests the breakdown of amide groups, compromising the epoxy network, leading to decreased mechanical properties. In terms of changes in other chemical groups, ether and oxirane groups also exhibit a tendency to degrade. However, the decrease in the integrated intensity of their associated vibrations is not statistically significant.

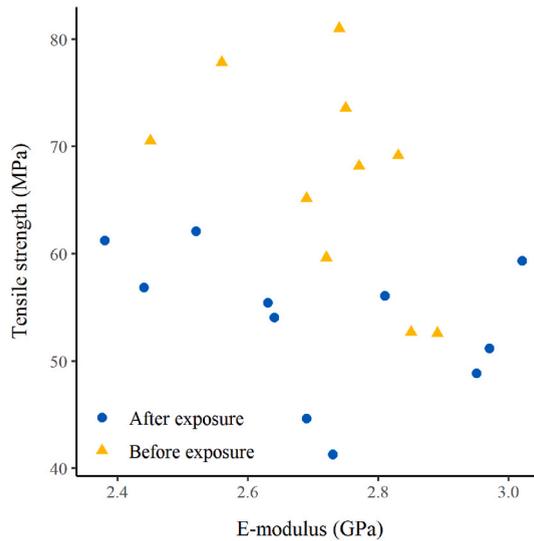
**Fig. 11.** Tensile properties of epoxy before and after exposure.

As a result of the cross-link degradation described in Section 3.2.1, the epoxy generally showed a reduction in tensile strength and elasticity following UV irradiation. Fig. 11 illustrates the tensile strength and E-modulus of the epoxy, comparing the values measured before and after exposure. As analysed using Student's *t*-test, the tensile strength decreased significantly after exposure (*p*-value = 0.0015), with a 20 % reduction in the average value. No significant change in the E-modulus was observed according to the *t*-test (*p*-

value = 0.8852), although a slight increase in the average value (by 0.4 %) was noted. The decreased tensile strength can be explained by the chain scission of aliphatic portions and degradation of amide crosslinks within the epoxy network discussed in Section 3.2.1. These changes in chemical groups led to a reduced crosslink density, weakening the structural integrity of the epoxy and consequently diminishing its ability to bear tensile loads.

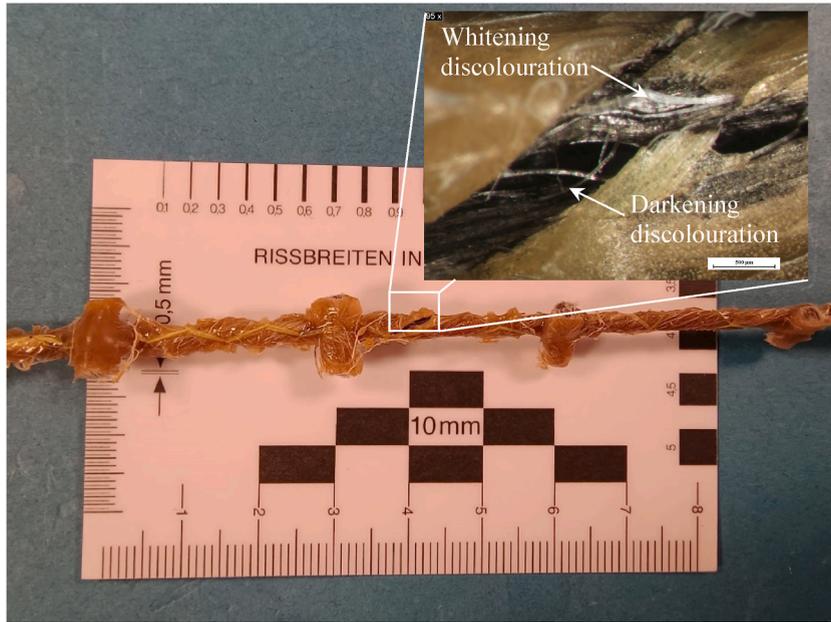
Fig. 12. Fractured FFRP after weathering exposure.

One FFRP sample was found to be fractured upon removal from the weathering chamber, as presented in Fig. 12. The fracture occurred on the external epoxy coating, accompanied by delamination between the epoxy coating and the flax fibre bundles. These issues primarily resulted from the differing hygroscopic properties and the corresponding mismatch in expansion coefficients between flax yarn and epoxy. The repeated absorption and evaporation of moisture created stress at the interface between the epoxy coating and the flax yarn. Over time, this cyclic stress caused delamination at the interface and fractures in the epoxy coating. The fracture of epoxy coating exposed flax fibres to the weathering condition. The exposed internal fibres exhibited similar discoloration phenomena as outlined in Section 3.1.1, with some fibres displaying whitening and others darkening. In contrast, the fibres that were not exposed to the environment, where the FFRP retained its integrity, maintained their original morphology.

As the reinforcement within RAC, epoxy coating fracture and debonding at the flax/epoxy interface may potentially compromise the long-term structural performance of the reinforced RAC. This degradation of interface integrity can reduce the efficiency of stress

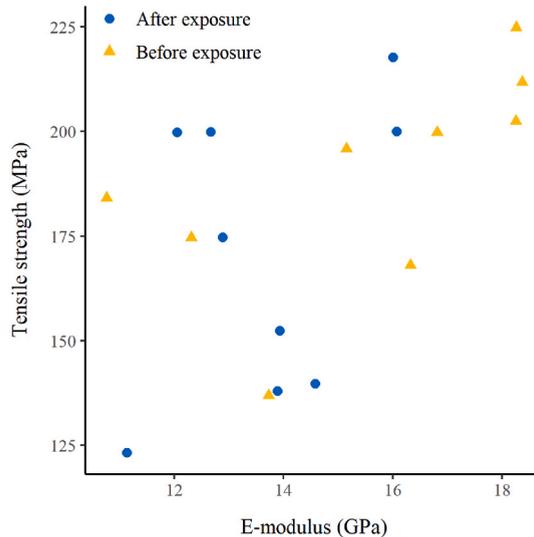
Fig. 13. Tensile properties of FFRP before and after exposure.

The FFRP samples that retained their integrity after weathering exposure were subjected to tensile testing. Fig. 13 illustrates a comparison of tensile properties between the exposed and unexposed samples. Although the exposed FFRP rods exhibited a 9 % decrease in average tensile strength and a 10 % decrease in average E-modulus compared to the unexposed rods, both reductions were not statistically significant according to the *t*-test (*p*-values = 0.2558 and 0.1367, respectively).

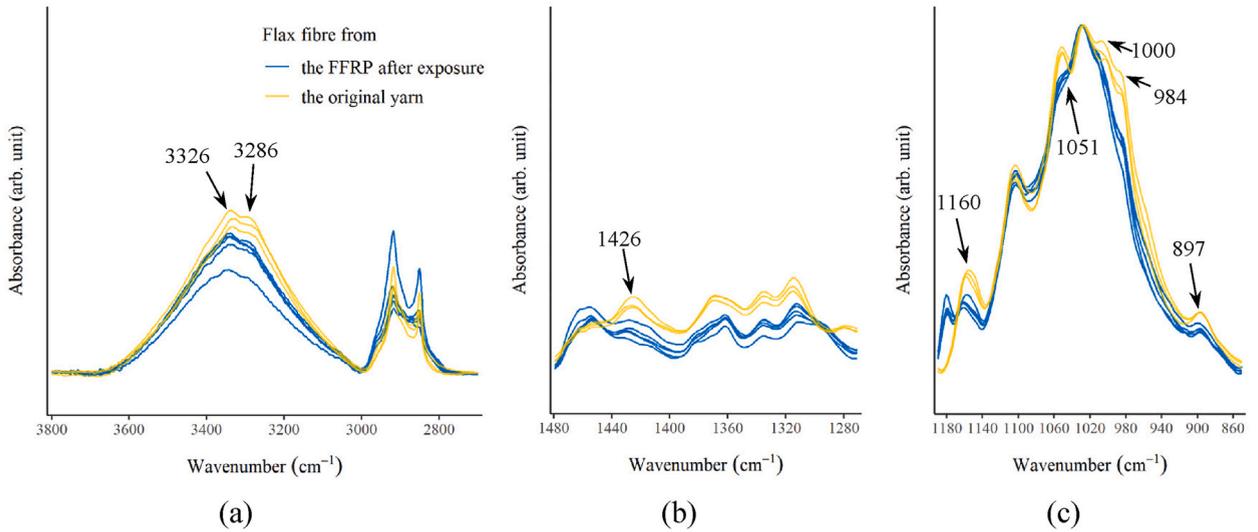
Fig. 14. Normalised FTIR spectra of flax fibre from the exposed FFRP compared to the original fibre: (a) 3800–2700  $\text{cm}^{-1}$ , (b) 1480–1280  $\text{cm}^{-1}$  and (c) 1190–850  $\text{cm}^{-1}$ .

Fig. 14 presents the normalised FTIR spectra of flax fibres extracted from both exposed FFRP and unexposed yarn, highlighting

regions with evident spectral changes. Significant differences in integrated intensity were observed at 3700–3000  $\text{cm}^{-1}$ , 1426  $\text{cm}^{-1}$ , 1160  $\text{cm}^{-1}$ , and 897  $\text{cm}^{-1}$ , with corresponding p-values of 0.0411, 0.0015, 0.0001, and 0.0003, respectively, as determined by the *t*-test. According to the assignments summarised in Table 4, all of these vibrations are associated with cellulose. Additionally, *t*-tests were not conducted on the bands at 1051, 1000 and 984  $\text{cm}^{-1}$ , as the vibrations at these wavenumbers in the FTIR spectra of the flax fibre extracted from FFRP were visibly diminished. Furthermore, although the bands at 2922 and 2853  $\text{cm}^{-1}$  for the fibre from exposed FFRP tended to fade (with the exception of one sample showing particularly sharp bands), the integrated intensity did not show a statistically significant decrease compared to that for the fibre before exposure. Due to epoxy residues on the fibre extracted from FFRP, additional bands were observed. One such band, around 1180  $\text{cm}^{-1}$ , is assigned to C–O stretching on the aromatic ring [76]. These epoxy residues also contribute to some inconclusive spectral changes. For instance, some fibres extracted from exposed FFRP exhibited a notable decrease in integrated intensity around 1740  $\text{cm}^{-1}$  compared to the original fibre, which could be linked to the degradation of hemicellulose or possibly the breakdown of aldehyde in epoxy. Meanwhile, other samples showed a visible increase in integrated intensity, potentially due to the presence of undegraded aldehyde in the epoxy.

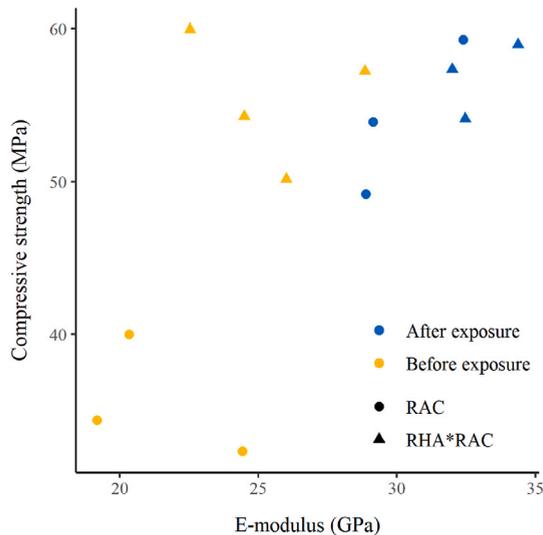
Fig. 15. Compressive properties of RAC and RHA\*RAC cylinders before and after exposure.

Fig. 15 presents the compressive strength and E-modulus of RAC and RHA\*RAC cylinders before and after the exposure. A two-way analysis of variance (ANOVA) was performed on both properties, with concrete type and weathering exposure considered as the two main factors. The analysis revealed that, for compressive strength, both concrete type and exposure were significant factors ( $p$ -value = 0.0008 and 0.0024, respectively) along with their interaction ( $p$ -value = 0.0043). The subsequent Tukey's HSD test indicated that RAC experienced a significant increase in compressive strength after exposure compared to its original strength (adjusted  $p$ -value = 0.0015), whereas RHA\*RAC showed no significant change (adjusted  $p$ -value = 0.9677). Meanwhile, the difference in compressive strength between RAC and RHA\*RAC shifted from significant before exposure (adjusted  $p$ -value = 0.0006) to non-significant after exposure (adjusted  $p$ -value = 0.8498). In terms of E-modulus, both concrete type and exposure were significant factors ( $p$ -value = 0.0231 and  $< 0.0001$ , respectively), while their interaction was not significant. The following Tukey's HSD test indicated a significant increase in the E-modulus of RAC after exposure compared to its original E-modulus (adjusted  $p$ -value = 0.0007), as well as in the E-modulus of RHA\*RAC (adjusted  $p$ -value = 0.0061). The E-modulus between RAC and RHA\*RAC did not differ significantly either before or after exposure (both adjusted  $p$ -values  $> 0.1$ ).

Generally, the compressive strength and E-modulus of RAC were significantly lower than those of RHA\*RAC before exposure. However, after exposure, both properties of RAC improved substantially, leading to non-significant differences when compared to RHA\*RAC. This aligns with our previous study [37], which reported that replacing 10 % of cement with RHA in RAC enhanced the compressive strength and E-modulus at 28 days compared to RAC without RHA. Additionally, the compressive strength of RAC continued to increase significantly after 91 days of storage under room conditions compared to its 28-day strength [37]. Although prolonged wet-dry cycling and UV irradiation can potentially cause surface degradation of concrete—and wet-dry cycling may lead to mechanical degradation through repeated swelling and shrinkage, leaching of soluble compounds, and associated sulfate, chloride, or other salt attacks—the exposure conditions in this study were relatively moderate and of short duration. Therefore, it is unlikely that significant mechanical degradation of the concrete occurred under these conditions. In this case, the compressive properties of the concrete were primarily governed by its hydration process, which tended to result in an increase in compressive strength and E-modulus. Many studies reported an increase in compressive strength or E-modulus of cement-based materials under wet-dry cycling [90,91], UV irradiation [24] and real outdoor condition for one year [92]. Regarding the changes in compressive properties of RHA\*RAC, no significant increase in the strength was observed after exposure. Given that the addition of RHA had already shown a significant effect on compressive strength prior to exposure, it is suspected that the filling effect of RHA primarily contributed to the

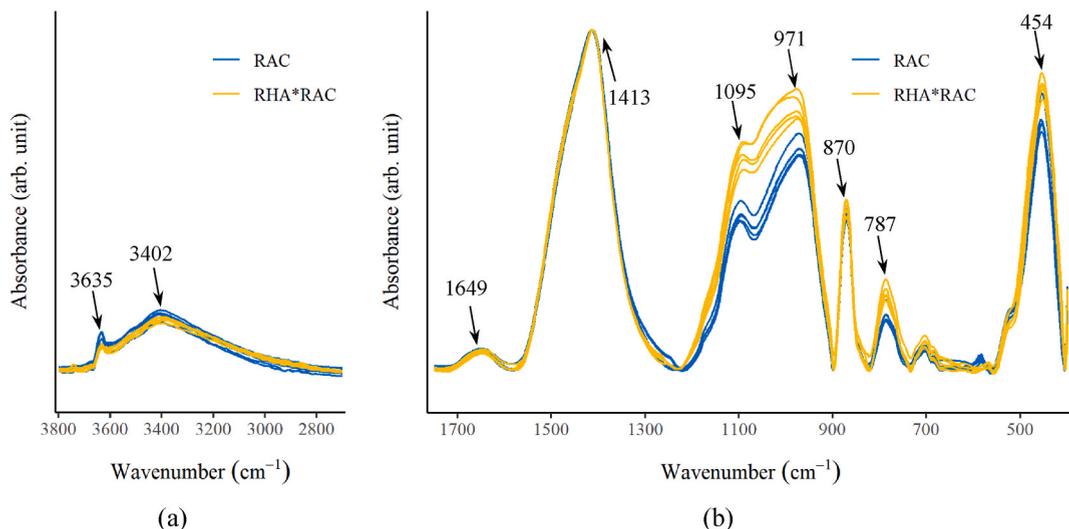
Fig. 16. Normalised FTIR spectra of the binder from RAC and RHA\*RAC after exposure: (a) 3800–2700  $\text{cm}^{-1}$  and (b) 1750–400  $\text{cm}^{-1}$ .

The FTIR spectra for binder extracted from RAC and RHA\*RAC after weathering exposure are illustrated in Fig. 16. The spectra were normalised based on the intensity of the vibration at  $1413\text{ cm}^{-1}$ , which is attributed to calcium carbonate formed through concrete carbonation [93–95]. This decision was made based on a previous study [38], which found no significant differences in carbonation depth between RAC and RAC incorporating RHA with a 10 % replacement ratio after up to 28 days of exposure in a carbonation chamber with a  $\text{CO}_2$  concentration of  $(70 \pm 5)\%$ . Table 7 shows the assignments of the corresponding vibrations, with the wavenumbers highlighted in red indicating significant differences in integrated intensity between RAC and RHA\*RAC, as determined by *t*-test. It revealed that significant differences occurred at  $3635$ ,  $1100\text{--}950$ ,  $787$  and  $454\text{ cm}^{-1}$  (all adjusted *p*-values  $< 0.05$ ). The notably lower  $\text{Ca}(\text{OH})_2$  content in the exposed RHA\*RAC compared to the exposed RAC, as evidenced by the peak at  $3635\text{ cm}^{-1}$ , is an expected outcome. This reduction is attributed to the pozzolanic reaction between the amorphous  $\text{SiO}_2$  in RHA and the  $\text{Ca}(\text{OH})_2$ , resulting in its consumption. The bands at  $1100\text{--}950$ ,  $787$  and  $454\text{ cm}^{-1}$  are all assigned to Si-O vibrations. Among these, the broad bands in the region of  $1100\text{--}950\text{ cm}^{-1}$  are associate to calcium silicate hydrate (C-S-H) [93,95], whereas the bands at  $787$  and  $454\text{ cm}^{-1}$  are more likely related to quartz or other silicate phases [93,95,96]. As shown in Table 1, the RHA contained more than 90 %  $\text{SiO}_2$ , some of which existed in crystalline phase as indicated in the X-ray diffraction pattern (Fig. 3 (b)). Therefore, the significant differences observed at  $787$  and  $454\text{ cm}^{-1}$  can be attributed to the crystalline  $\text{SiO}_2$  present in RHA. Additionally, the amorphous  $\text{SiO}_2$  in RHA contributed to increased formation of pozzolanic reaction products, such as C-S-H and other silicates, resulting in a considerable increase in the integrated intensity at  $1100\text{--}950$ ,  $787$  and  $454\text{ cm}^{-1}$ .

Overall, compared to RAC, RHA\*RAC contained a higher amount of C-S-H (and other silicate phases) and crystalline  $\text{SiO}_2$ , while having a lower amount of  $\text{Ca}(\text{OH})_2$ . C-S-H is the primary binding phase in concrete, responsible for its strength. Although crystalline  $\text{SiO}_2$  does not participate in the pozzolanic reaction, its small particle size (as shown in Fig. 3 (a)) allows it to fill the pores in the concrete, resulting in a denser microstructure. These are the main factors contributing to the higher compressive strength and E-modulus of RHA\*RAC compared to RAC, although the differences in both properties are not statistically significant after exposure (both adjusted *p*-value  $> 0.1$ ). On the contrary, RHA\*RAC exhibited a significantly higher compressive strength than that of RAC before exposure (adjusted *p*-value = 0.0006). This suggests that the filling effect of RHA played a primary role in improving the compressive strength of RAC, as the pozzolanic reaction of RHA takes place over a longer timescale compared to the hydration process of cement.

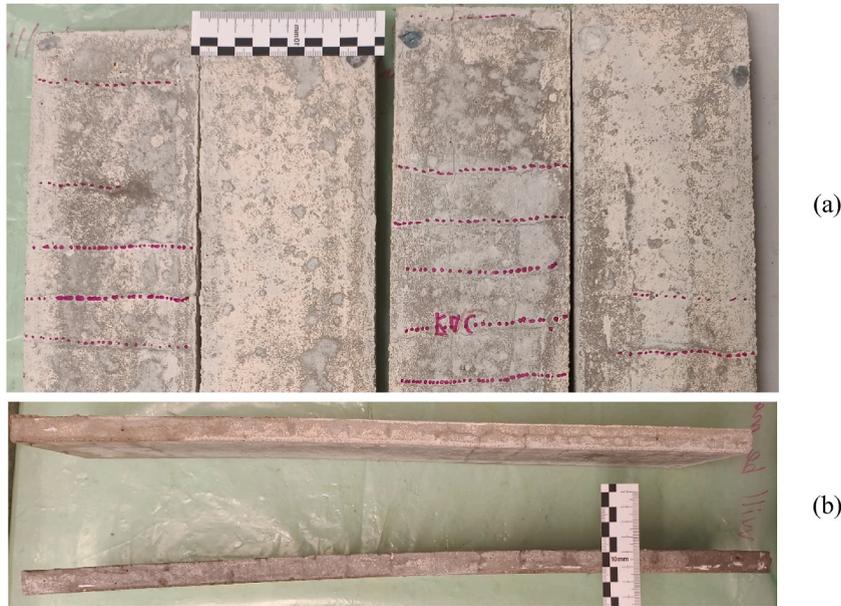
**Fig. 17.** Surface morphology of FFRP-RAC and FFRP-RHA\**RAC* after the weathering exposure: (a) front and (b) side view.

Upon being removed from the climate chamber, all FFRP-reinforced RAC samples exhibited visible cracks. Fig. 17 illustrates the general cracking pattern, with horizontal and longitudinal cracks forming on each side. Basically, the cracks developed along the reinforcement rods, suggesting that the cracks formed due to differential moisture expansion between the concrete and the FFRP reinforcement. Literature indicates that flax fibre reinforced epoxy composites can experience thickness swelling of up to 4 % at 100 % relative humidity [97], while the wet expansion of concrete can reach as high as  $40\text{ }\mu\text{e}$  [98]. Additionally, the curvature of the panel, visible in Fig. 17 (b), may also be attributed to the differential swelling between the RAC and the FFRP reinforcement. This discrepancy in expansion and contraction induces internal stresses, leading to overall deformation.

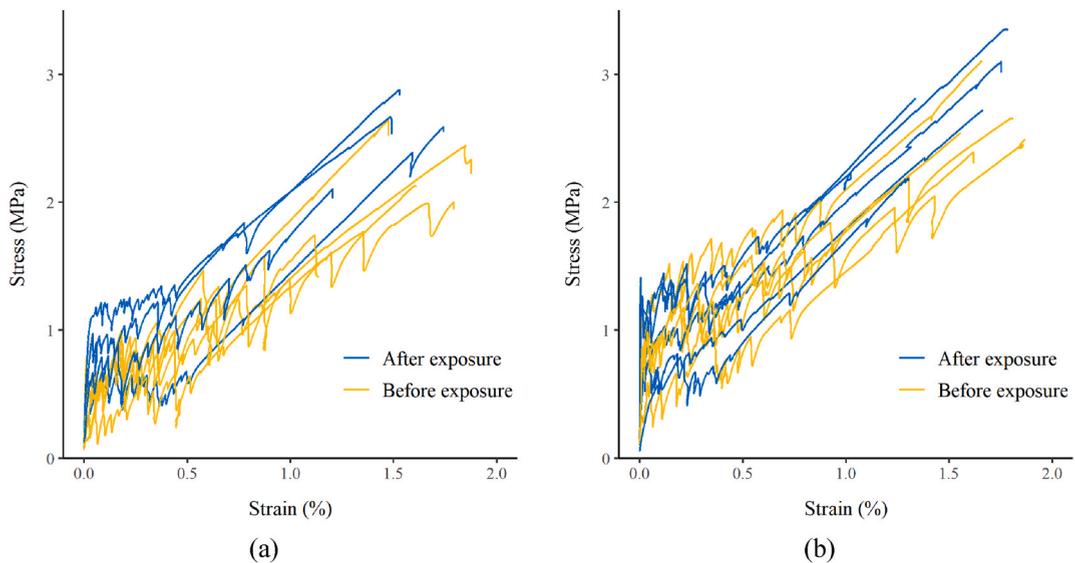
**Fig. 18.** Stress-strain responses under uniaxial tensile load before and after weathering exposure for: (a) FFRP-RAC and (b) FFRP-RHA\**RAC*.

Fig. 18 illustrates the stress-strain responses of FFRP-RAC and FFRP-RHA\*RAC subjected to uniaxial tensile loading both before and after the weathering exposure. The corresponding parameters including tensile strength, toughness (calculated as the area under the stress-strain curve) and ultimate strain are presented in Table 8. Two-way ANOVA followed by Tukey's HSD test was conducted on all parameters. It only revealed that the addition of RHA is a significant main factor for the tensile strength (*p*-value = 0.0341), and the post hoc analysis found no significant differences between any of the groups at the significance level of 0.05 for any parameter. One difference was found to be significant at a level of 0.1, specifically in the tensile strength between FFRP-RAC before exposure and FFRP-RHA\*RAC after exposure (adjusted *p*-value = 0.0523). The statistical analysis indicates that the weathering exposure up to 30 weeks has no significant effect on the tensile properties of FFRP-RAC or FFRP-RHA\*RAC. However, the addition of RHA in RAC shows potential for preserving the tensile load capacity of the FFRP reinforced RAC. Further details will be discussed in the following paragraph.

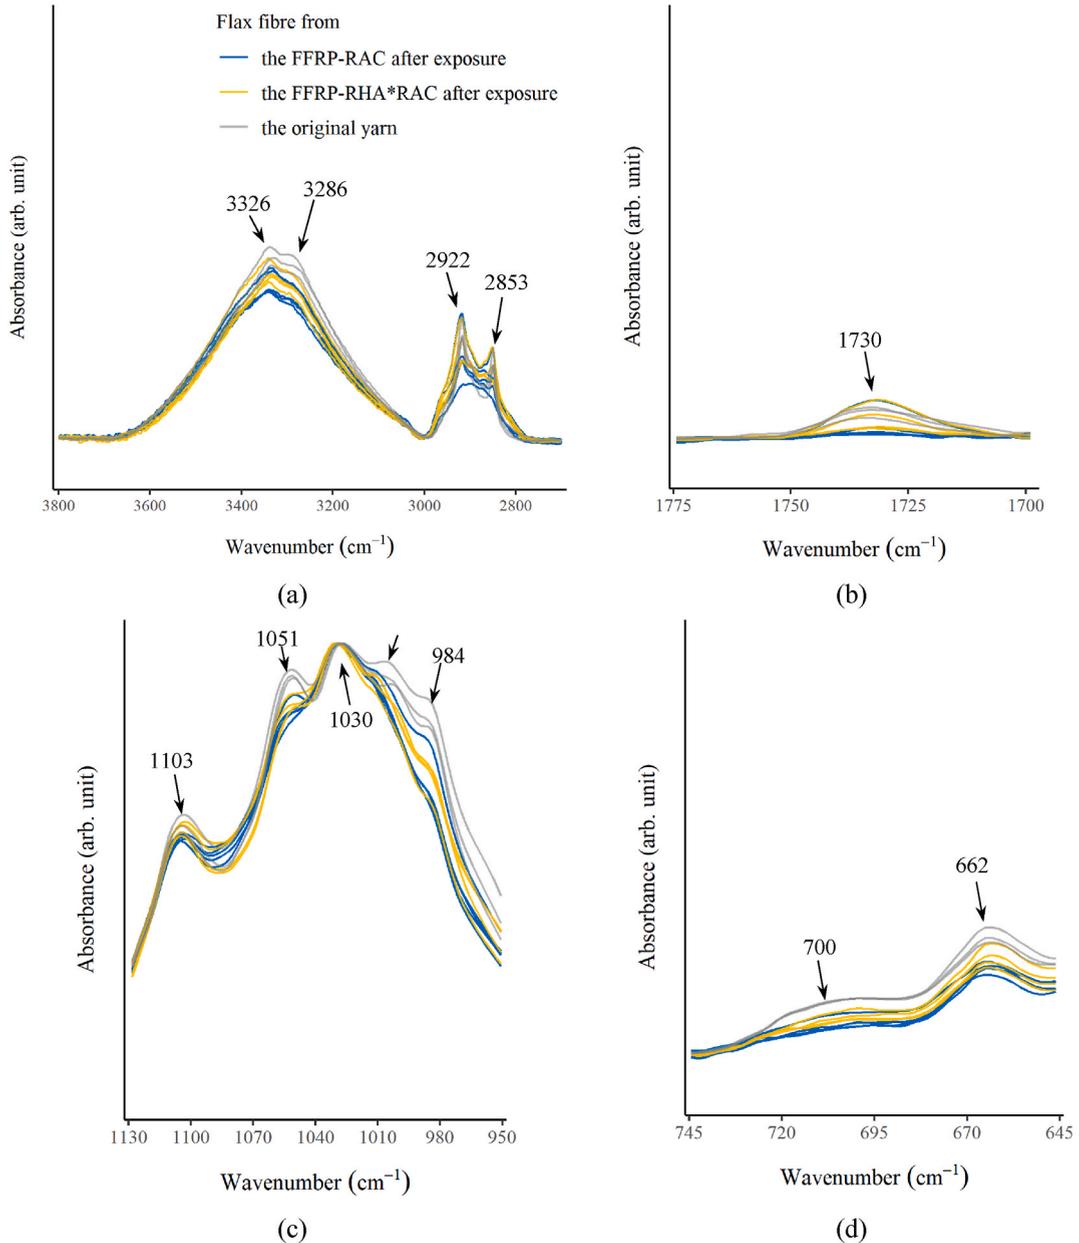
**Fig. 19.** Normalised FTIR spectra of flax fibres extracted from the exposed FFRP-RAC and FFRP-RHA\**RAC* compared to the original fibre: (a) 3800–2700 cm<sup>-1</sup>, (b) 1775–1700 cm<sup>-1</sup>, (c) 1130–950 cm<sup>-1</sup> and (d) 745–645 cm<sup>-1</sup>.

Flax fibres extracted from exposed FFRP-RAC and FFRP-RHA\*RAC were analysed using FTIR and compared to the original fibres. Fig. 19 presents the normalised spectra across various regions, highlighting evident differences among the groups. The integrated intensity of vibrations was calculated, and the significance of differences between groups was assessed using ANOVA, followed by Tukey's HSD test. Significant differences at the  $\alpha = 0.05$  level were observed in the regions of  $3600\text{--}3000\text{ cm}^{-1}$ ,  $1730\text{ cm}^{-1}$  and  $700\text{ cm}^{-1}$ , where the flax fibre from FFRP-RAC exhibited a significant decrease in integrated intensity compared to the original fibre (*p*-values = 0.0325, 0.0161 and 0.0002, respectively). The fibre from FFRP-RHA\*RAC also showed a significantly reduced integrated intensity compared to the original fibre at  $700\text{ cm}^{-1}$  (*p*-value = 0.0014). According to Table 4, these findings suggest that the flax fibre embedded in FFRP-RAC underwent significant degradation in hemicellulose and cellulose crystallinity after exposure. In contrast, the fibre from FFRP-RHA\*RAC exhibited a more moderate level of degradation. Notably, at  $1730\text{ cm}^{-1}$ , the integrated intensity for the fibre from FFRP-RAC is nearly zero, whereas the vibration for the fibre from FFRP-RHA\*RAC remains relatively pronounced. Additionally, statistical analysis was not performed for the vibrations in the  $1130\text{--}950\text{ cm}^{-1}$  region, as the peaks at  $1051\text{ cm}^{-1}$ ,  $1000\text{ cm}^{-1}$ ,

and 984 cm<sup>-1</sup>—associated with cellulose or polysaccharides—were visibly diminished in the flax fibres from exposed FFRP-RAC and FFRP-RHA\**RAC* compared to the original fibre. Given the near-zero UV transmittance of concrete, the chemical degradation of flax fibres is primarily attributed to alkaline hydrolysis induced by the concrete environment. The FTIR results indicate that incorporating
